# Plate Heat Exchanger

ID: 9649

Industry: Marine  
Application: HEX-Heat Exchangers  
Substrate: Carbon steel  
Products: Belzona 1511 (Super HT-Metal), Belzona 1593

Corrosion due to salt water environment on end plates of plate heat exchangers.

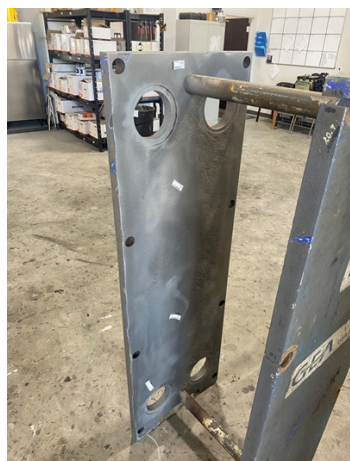
Areas to be rebuilt/coated were checked for chlorides, chlorides were neutralized to acceptable levels, units were blasted and profile checked as per product manufactures recommendations.

Repair areas were abrasive blasted, and chlorides were checked and neutralized to acceptable levels prior application of Belzona 1511/1593 System

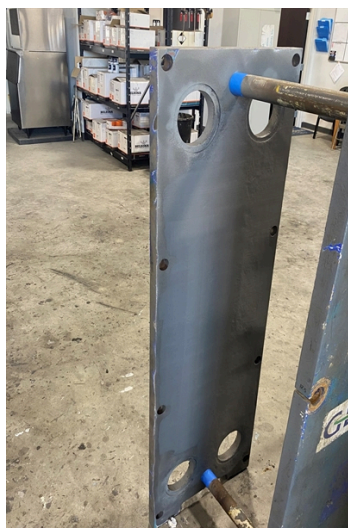
Application of 1511 to fill in pitted and corroded areas prior to coating.

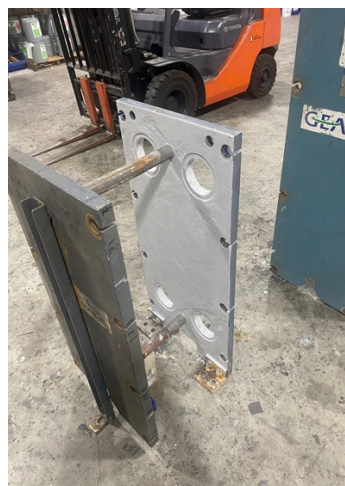
Application of first coat of 1593

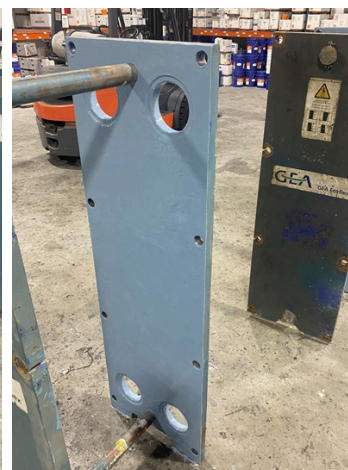
Application of 2nd coat 1593
