Plate Heat Exchanger

ID: 9649

Industry: Marine
Application: HEX-Heat Exchangers
Substrate: Carbon steel
Products: Belzona 1511 (Super HT-Metal), Belzona 1593

Customer Location: Houma, Louisiana
Application Date: April 2024

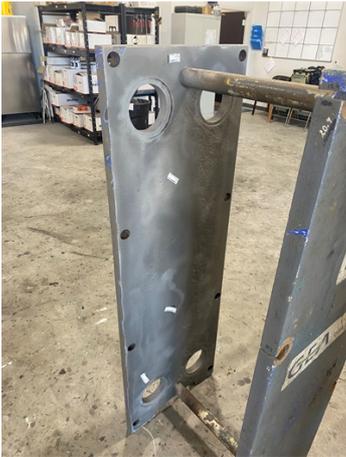
Areas to be rebuilt/coated were checked for chlorides, chlorides were neutralized to acceptable levels, units were blasted and profile checked as per product manufactures recommendations.

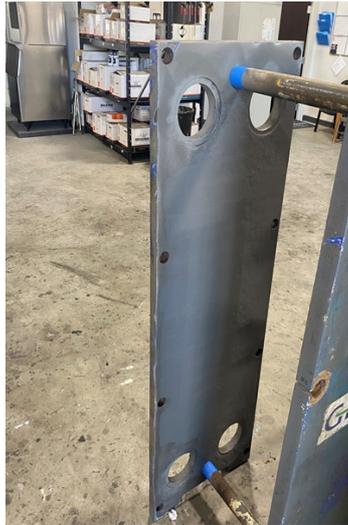
Application of 1511 to fill in pitted and corroded areas prior to coating.

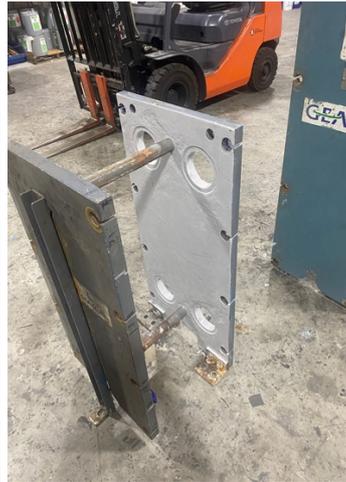
Application of first coat of 1593

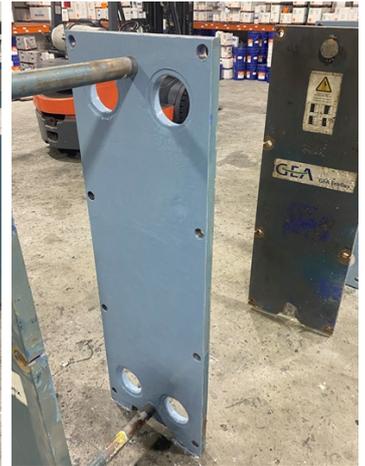
Application of 2nd coat 1593
