Belzona coating for mill scale wastewater channel in steel industry

ID: 9656

Industry: *Steel & Metal Processing*
Application: *SHM-Solids Handling Machinery*

Substrate: *Concrete*
Products: *Belzona 1814*

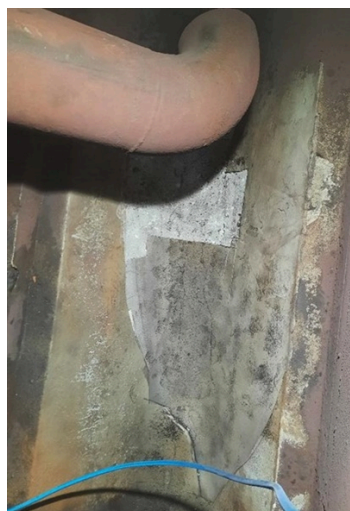
The competitor's repair was failing mainly between the concrete and the primer, but some delamination also occurred between the middle and top layer.

Damaged substrate

First the failing competitor coating had to be removed.

To prepare the substrate for the Belzona solution, the concrete substrate was grit blasted.
