Test Separator Internal Coating

ID: 9657

Industry: Oil & Gas
Application: TCC-Tanks and Chemical Containment Areas
Substrate: Carbon steel
Products: Belzona 1511 (Super HT-Metal), Belzona 1593

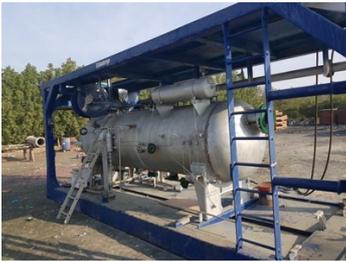
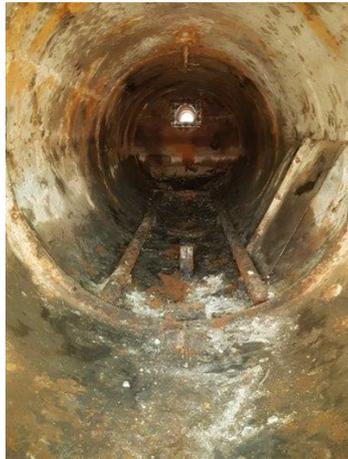
The test separator's internal surfaces suffered severe corrosion.

Internal surfaces were heavily corroded due to aggressive media.

Evidence of severe corrosion damage on test separator internal surfaces

1. Rebuild the worn metal with Belzona 1511
2. Topcoat the internal substrate with Belzona 1593 to fully protect the surface from further attacks.

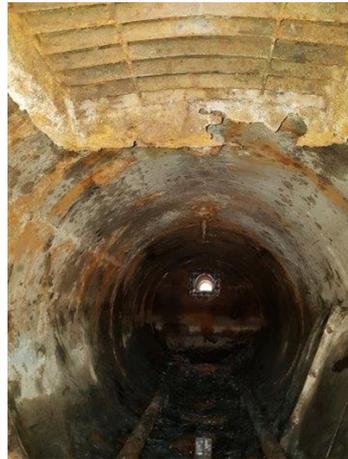
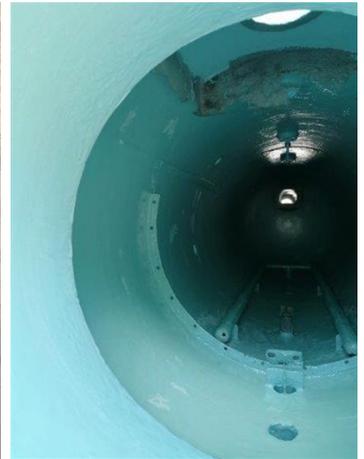
Complete application of Belzona solution on test separator internal surfaces
