# Belzona 1111 for Flange Face Repair

ID: 9659

Industry: Oil & Gas  
Application: VPF-Valves, Pipes and Fittings  
Substrate: Carbon steel  
Products: Belzona 1111 (Super Metal)

Customer Location: Saudi Arabia  
Application Date: February 2021

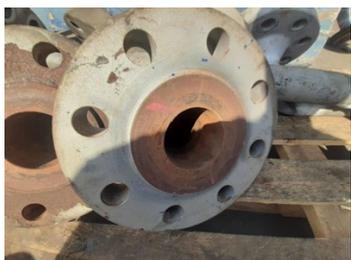
Worn-out flange face needs to be repaired

Worn-out flange face need repair

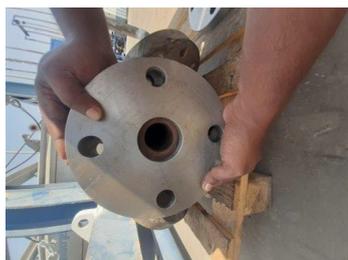
Forming technique was used to rebuild the flange face

Using the forming technique to apply Belzona 1111 (Super Metal) to achieve a seamless, high-performance repair.
