Belzona 1111 for Flange Face Repair

ID: 9659

Industry: Oil & Gas
Application: VPF-Valves, Pipes and Fittings
Substrate: Carbon steel
Products: Belzona 1111 (Super Metal)

Customer Location: Saudi Arabia
Application Date: February 2021

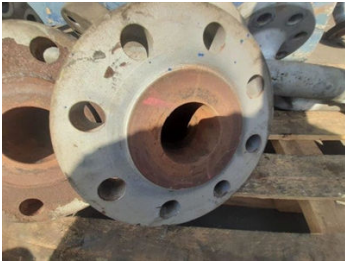
Worn-out flange face needs to be repaired

Worn-out flange face need repair

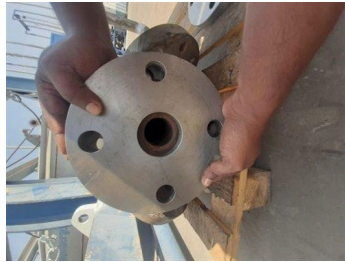
Forming technique was used to rebuild the flange face

Using the forming technique to apply Belzona 1111 (Super Metal) to achieve a seamless, high-performance repair.

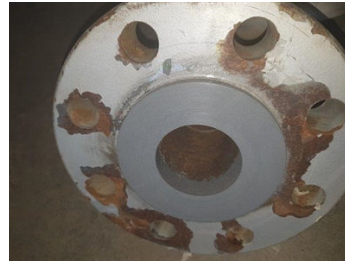
Flange face was successfully restored and ready for service

The repair was completed in one day, allowing the equipment to be back in service on the next day. With Belzona solution, the asset owner can minimize downtime and maximize efficiency of the equipment.
