Pipe bridge support repairs

ID: 9663

Application: FPA-Floor Problem Areas

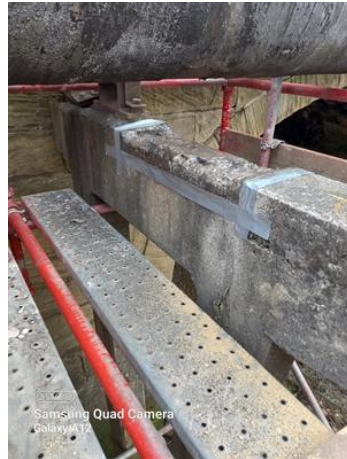
Several pipe supports had corroded and no longer provided support for the pipeline running across this bridge section.

Corroded pipe support

The areas were marked out, prepared, conditioned with Belzona 4911 & then repaired with Belzona 4111. For a larger area a shutter was built around & Belzona 4111 poured into to fill up to the desired level.

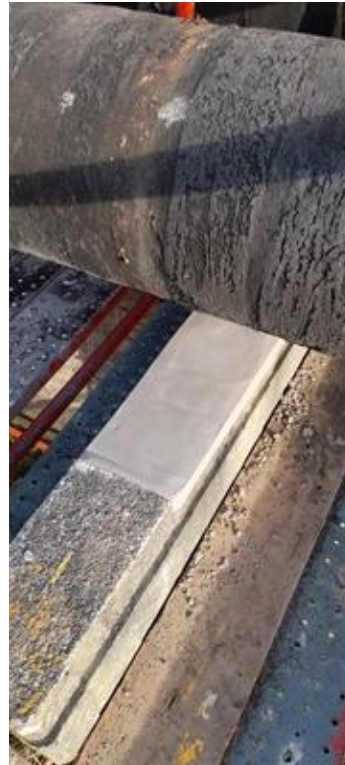
Area prepared

Completed section

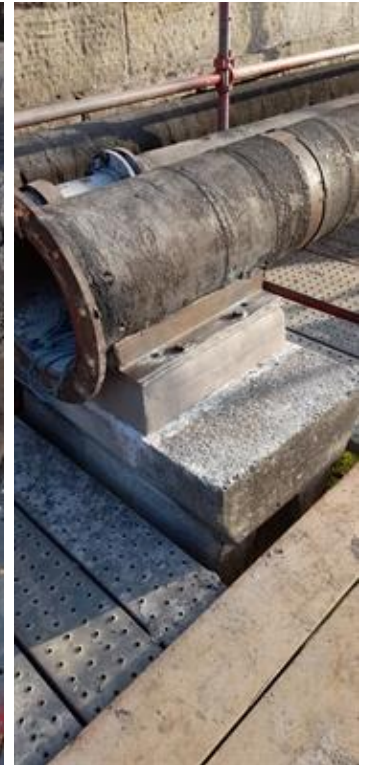
Larger support repaired using shutter & pour method
