Belzona 3131 long term roof protection

ID: 9664

Industry: *Water / Wastewater*
 Application: *RPA-Roof Problem Areas*
 Substrate: *Other*
 Products: *Belzona 3131 (WG Membrane)*

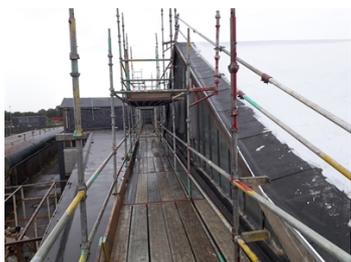
Belzona 3131 application

The roofs were first power washed, treated with fungicide. Two coats of Belzona 3131 WG Membrane were then applied.

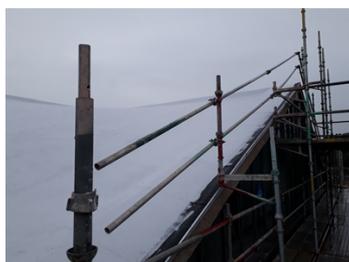
Application underway

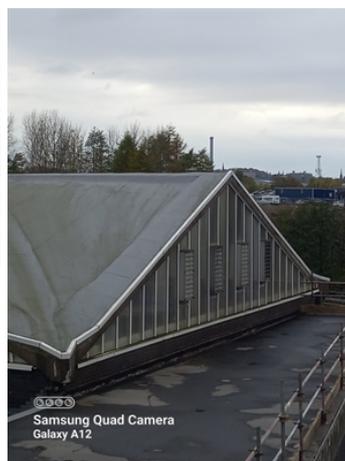
Roof section after 4 years
service

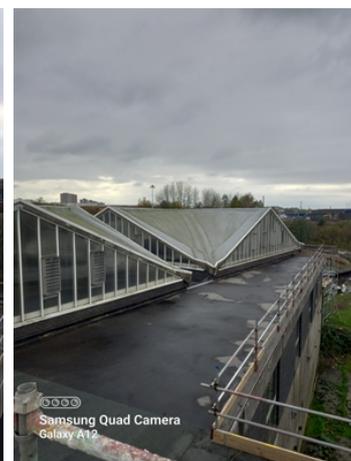
Still in excellent condition
