Belzona 3131 long term roof protection

ID: 9664

Industry: *Water / Wastewater*
 Application: *RPA-Roof Problem Areas*
 Substrate: *Other*
 Products: *Belzona 3131 (WG Membrane)*

Customer Location: *Scotland*
 Application Date: *July 2020*

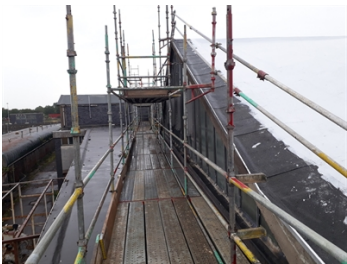
Two large roofs were experiencing leaks due to ageing mineral felt. This was causing issues to the operations inside the buildings.

Belzona 3131 application

The roofs were first power washed, treated with fungicide. Two coats of Belzona 3131 WG Membrane were then applied.

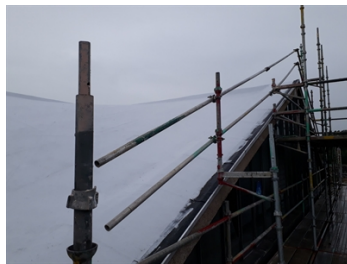
Application underway

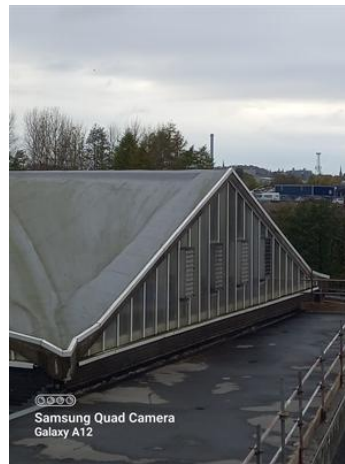
Roof section after 4 years
service

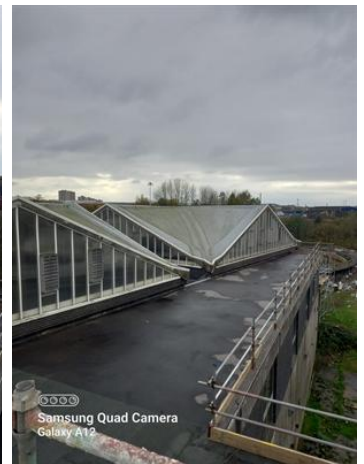
Still in excellent condition
