# PROCESS WATER TANK LINING RESTORATION

ID: 9667

Application: *TCC-Tanks and Chemical Containment Areas*

Application Date: *October 2024*

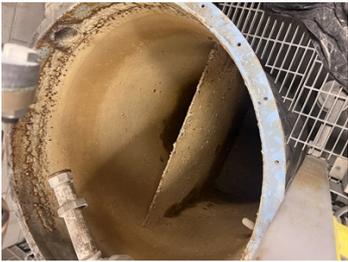
Tank before refurbishment.

Lining of process tank was experiencing deterioration due to erosion corrosion and required to be cleaned and protected from further damage.

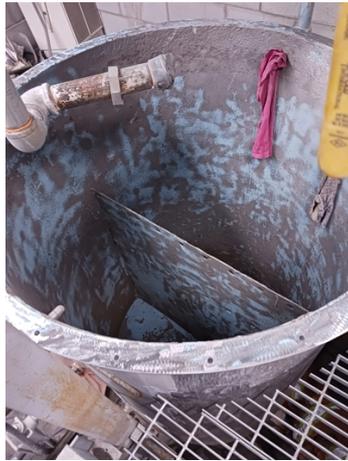
Lining after abrasive blasting.

The lining was cleaned to the required level of cleanliness by abrasive blasting and the external by power tool cleaning. The tank was further cleaned and degreased by using Belzona 9111. Two coats application of Belzona 1341 was applied as lining while two coats of Belzona 6111 primer and two coats of Belzona 5111 was applied as coating.

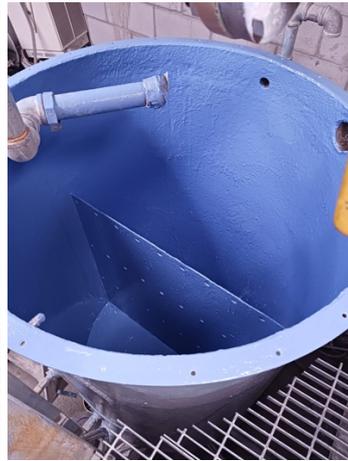
Lining after two coats of Belzona 1341.

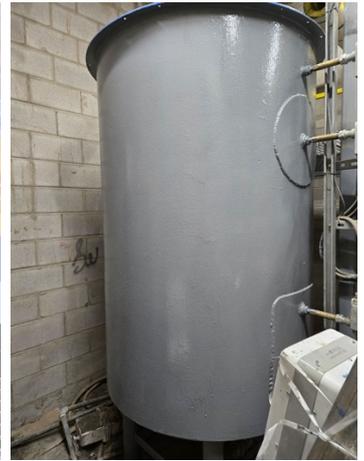
After application of external coating.
