Belzona Prevents Plant Shutdown By Curtailing High Pressure Pipe Leak

ID: 9671

Application: VPF-Valves, Pipes and Fittings

Substrate: Carbon steel

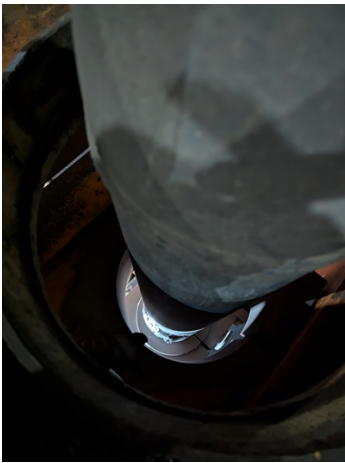
Pipe after surface preparation.

The affected area was cleaned to the required level of cleanliness as stated in the products IFU and procedure for repairing leaks in pipes (VPF-11) by abrasive blasting. Belzona 1212 was used to cover both the weld seams and the metal plate before wrapping with Belzona super wrap II kits.

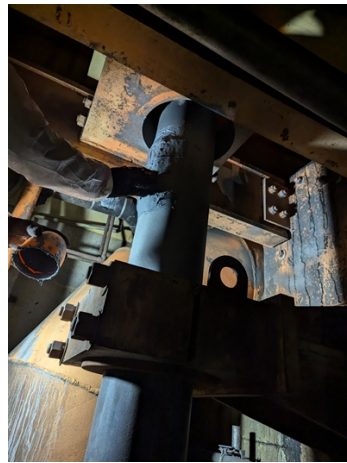
Pipe and metal plate covered with Belzona 1212.

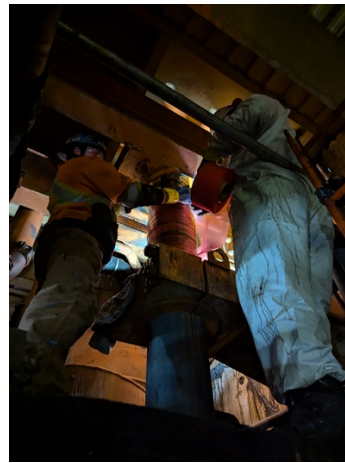
Super Wrap II was installed.
