Belzona Repairs and Protects the Sea Strainer

Industry: *Marine*
Application: *SOS-Ships and Offshore Structures*

Substrate: *Carbon steel*
Products: *Belzona 1111 (Super Metal), Belzona 1321 (Ceramic S-Metal)*

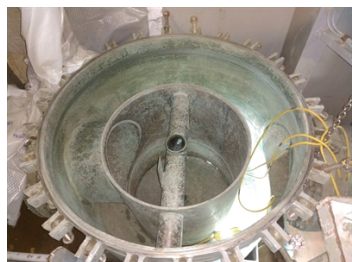
The two sea strainers had heavy erosion/corrosion including metal loss and holes between chambers.

Original condition, note the light passing through into the inner chamber through heavy corrosion.

Grit blasting to the standards set forth in the instructions for use, washed thoroughly with acetone, and then the first coat of Belzona 1321 was applied by brush. Belzona 1111 was applied to repair the eroded damage and areas of deep pitting before the second coat of Belzona 1321 was applied by brush.

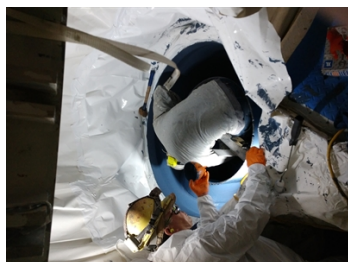
Applying the Belzona 1321 inside the sea strainer.

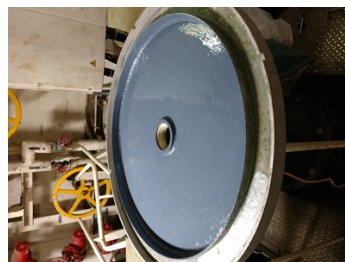
Belzona 1321 applied to the internal chamber lid.

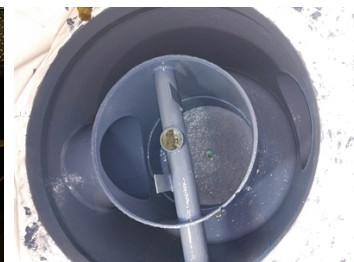
Sea strainer application complete.

This repair was completed in just a couple of days working within the overcoat window of the Belzona 1321. This quick turnaround allowed the sea strainer to be put back together sooner than was originally planned. This Belzona solution did not require any extra time or specialized tools and gave the customer an improved repair with better protection than it had originally.
