## Belzona Prevents Wear on a Seafood Processor

ID: 9688

Industry: *Marine*  
 Application: *SOS-Ships and Offshore Structures*

Customer Location: *Seattle Washington*  
 Application Date: *May 2017*

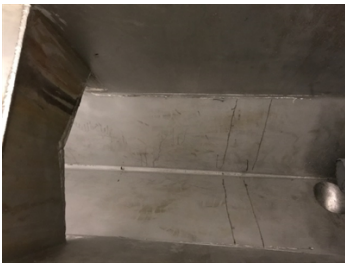
*This seafood waste chopper was wearing down from many years of use resulting on the shaft getting bowed and causing the large heavy chopper head to jam.*

Original condition.

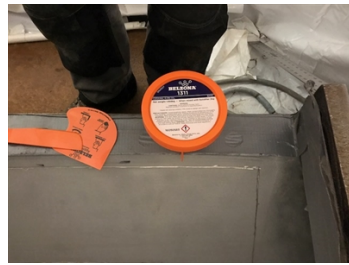
Ready to apply the Belzona 1311.

The surface was grit blasted and washed with solvent, and then the Belzona 1311 was carefully applied by hand in a thin smooth layer.

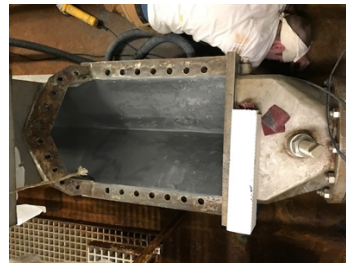
Application complete.

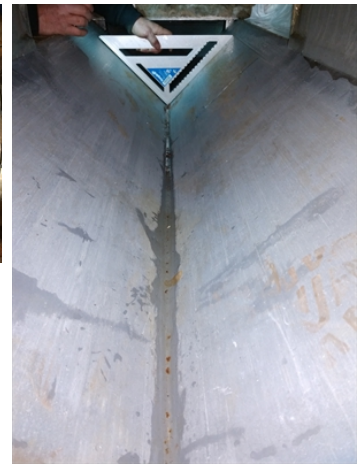
One year later showing the channel is still true and square.
