Belzona Prevents Wear on a Seafood Processor

Industry: *Marine*
 Application: *SOS-Ships and Offshore Structures*

Customer Location: *Seattle Washington*
 Application Date: *May 2017*

Substrate: *Stainless-steel*
 Products: *Belzona 1311 (Ceramic R-Metal)*

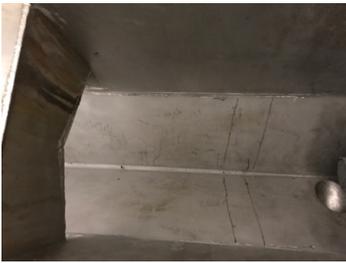
This seafood waste chopper was wearing down from many years of use resulting on the shaft getting bowed and causing the large heavy chopper head to jam.

Original condition.

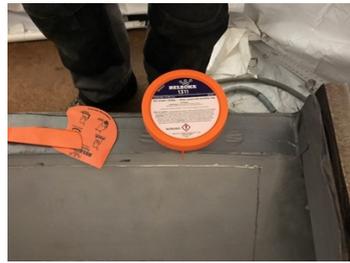
Ready to apply the Belzona 1311.

The surface was grit blasted and washed with solvent, and then the Belzona 1311 was carefully applied by hand in a thin smooth layer.

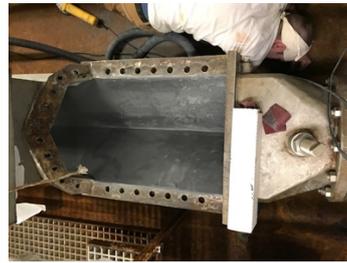
Application complete.

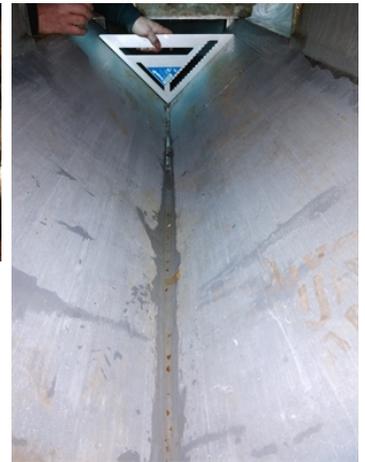
One year later showing the channel is still true and square.
