Belzona Stops the Corrosion Inside of a Tunnel.

Industry: Water / Wastewater

Customer Location: Seattle Washington

Application: VPF-Valves, Pipes and Fittings

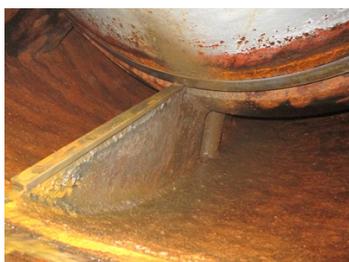
Corrosion on this reservoir valve was getting bad, so a stainless steel runner was attached, which resulted in dissimilar metals corrosion which increased the damage rapidly.

Initial inspection, after use of a wire wheel to see the corrosion damage.

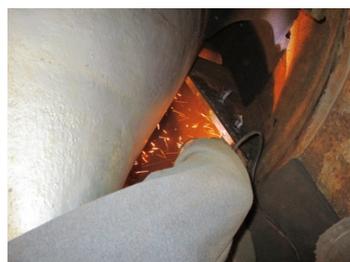
Grinding for surface preparation.

Battery operated hand tools were used to clean and roughen the application areas. The areas were then washed down with solvent, and the Belzona 1311 and Belzona 1321 were applied by brush.

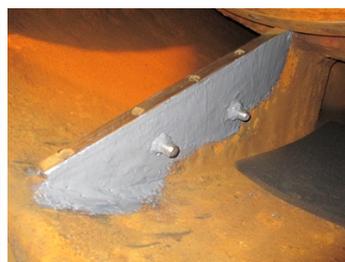
Belzona 1311 applied to the corroded areas and over coated with Belzona 1321.
