## Belzona Stops the Corrosion Inside of a Tunnel.

Industry: Water / Wastewater

Application: VPF-Valves, Pipes and Fittings

Substrate: Carbon steel

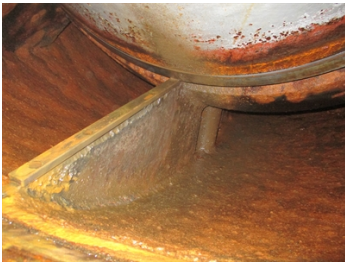
Corrosion on this reservoir valve was getting bad, so a stainless steel runner was attached, which resulted in dissimilar metals corrosion which increased the damage rapidly.

Initial inspection, after use of a wire wheel to see the corrosion damage.

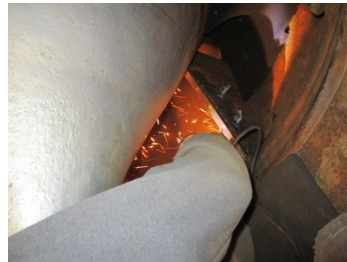
Grinding for surface preparation.

Battery operated hand tools were used to clean and roughen the application areas. The areas were then washed down with solvent, and the Belzona 1311 and Belzona 1321 were applied by brush.

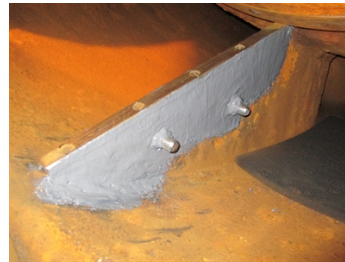
Belzona 1311 applied to the corroded areas and over coated with Belzona 1321.
