# Oil leak in transformer sealed at major power distribution facility

ID: 9690

Customer Location: Kingston, Ontario

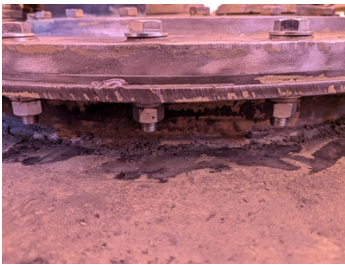
Surface preparation of the area.

The oil was lowered a bit and then the surface was degreased as good as possible and abraded to create a rough surface. Belzona 1161 was mixed and applied around the bolts and the flange. Then Belzona 5831LT was applied to seal the entire surface. However, the next morning the customer applied pressure to the system, and they saw a few areas that needed to be reinforced. We decided to pack the whole area with 4141 and then apply 5831LT to encapsulate everything. The system was tested again, and no leaks were found.

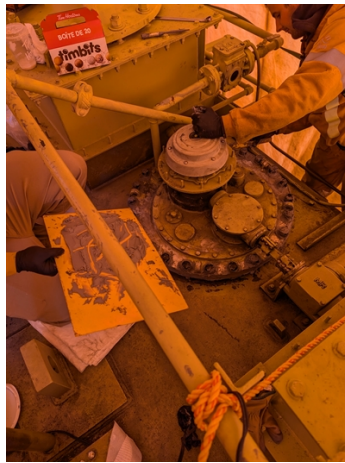
Sealing the leak with Belzona 1161

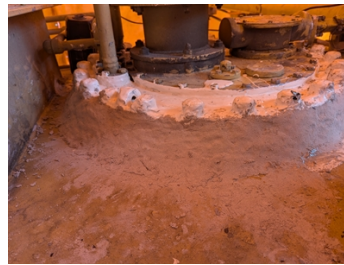
Rebuilding the entire area with Belzona 4141

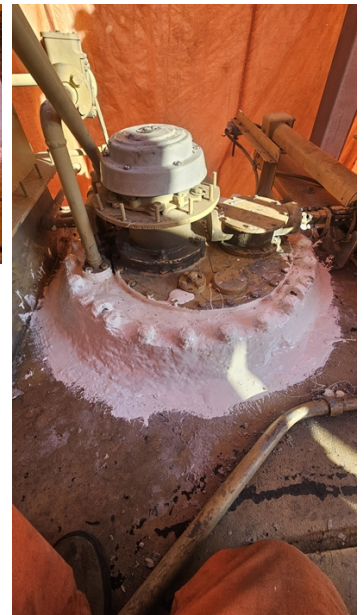
After application of Belzona 5831LT

The customer has used Belzona multiple times for such repairs. They are very pleased with not only the performance of our products, but also the support we offer them onsite training their staff and making sure they are comfortable applying our products. We followed up on the repair one month later and the system is operating without leaks
