# Oil leak in transformer sealed at major power distribution facility

ID: 9690

Application: MPT-Mechanical Power Transmission

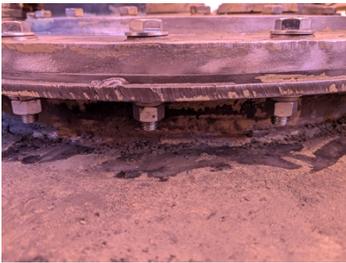
Surface preparation of the area.

The oil was lowered a bit and then the surface was degreased as good as possible and abraded to create a rough surface. Belzona 1161 was mixed and applied around the bolts and the flange. Then Belzona 5831LT was applied to seal the entire surface. However, the next morning the customer applied pressure to the system, and they saw a few areas that needed to be reinforced. We decided to pack the whole area with 4141 and then apply 5831LT to encapsulate everything. The system was tested again, and no leaks were found.

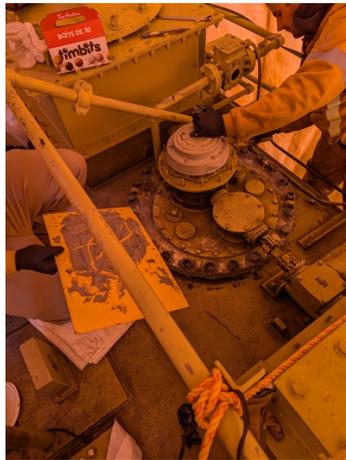
Sealing the leak with Belzona 1161

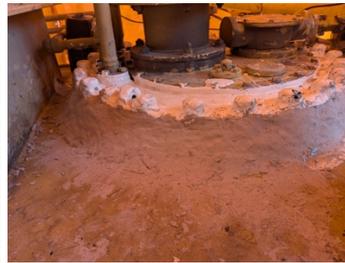
Rebuilding the entire area with Belzona 4141

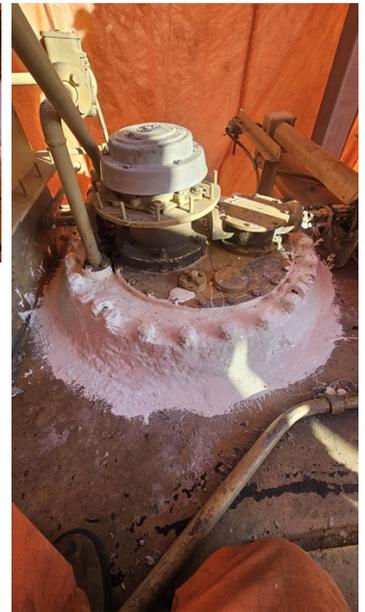
After application of Belzona 5831LT

The customer has used Belzona multiple times for such repairs. They are very pleased with not only the performance of our products, but also the support we offer them onsite training their staff and making sure they are comfortable applying our products. We followed up on the repair one month later and the system is operating without leaks
