## Repairing a leaky crack in a hot oil system

**Application:** VPF-Valves, Pipes and Fittings

**Substrate:** Carbon steel

**Products:** Belzona 1221 (Super E-Metal), Belzona 1511 (Super HT-Metal)

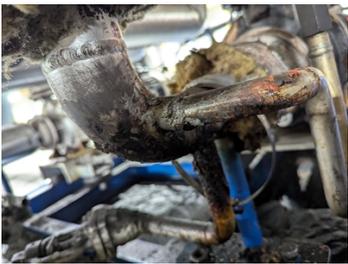
Substrate after surface preparation.

The oil was still seeping at the moment of application, so we needed to stem the leak first. Thus, after doing surface preparation we stemmed the leak with Belzona 1221, thanks to its fast-curing properties. Then we proceed to do a few wraps of Belzona 1511 with Belzona 9341.

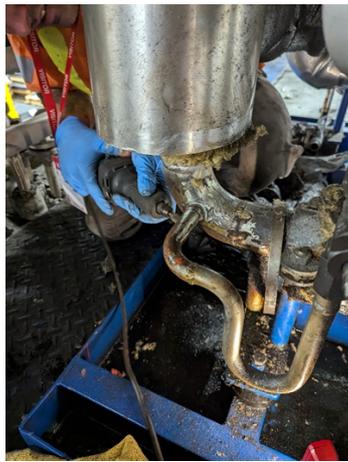
Sealing with Belzona 1221.

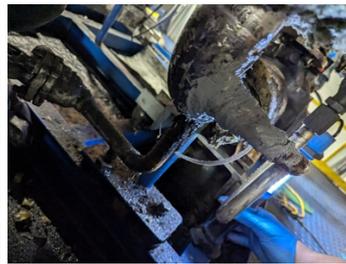
Rebuilding with Belzona 1511.

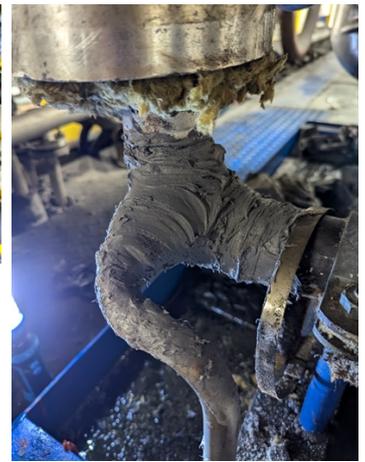
Entire area covered with Belzona 1511.
