Repairing a leaky crack in a hot oil system

ID: 9691

Application: VPF-Valves, Pipes and Fittings

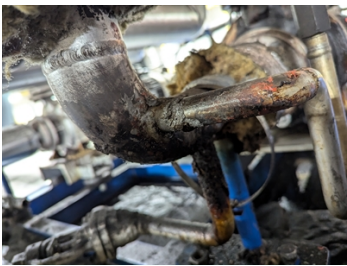
Substrate after surface preparation.

The oil was still seeping at the moment of application, so we needed to stem the leak first. Thus, after doing surface preparation we stemmed the leak with Belzona 1221, thanks to its fast-curing properties. Then we proceed to do a few wraps of Belzona 1511 with Belzona 9341.

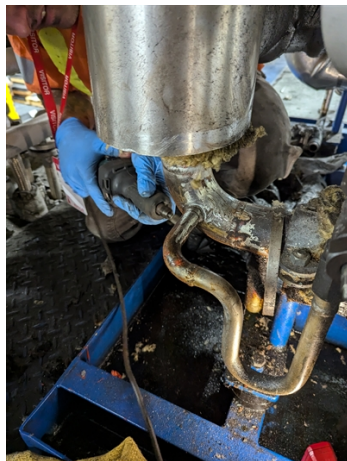
Sealing with Belzona 1221.

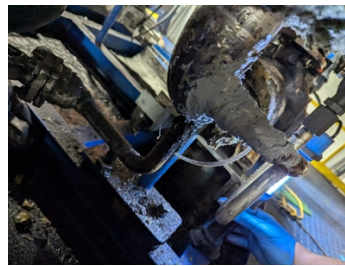
Rebuilding with Belzona 1511.

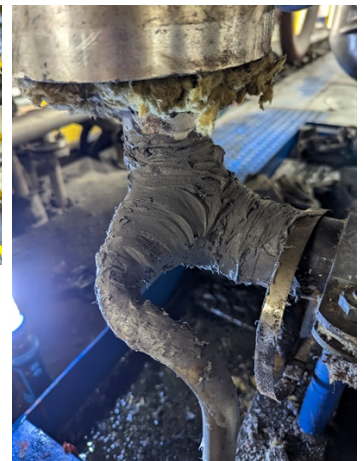
Entire area covered with Belzona 1511.
