## Belzona Saves Salt Hopper in a Municipal facility.

ID: 9694

**Industry:** Local Authorities & Municipalities  
**Application:** TCC-Tanks and Chemical Containment Areas  
**Substrate:** Carbon steel  
**Products:** Belzona 6111 (Liquid Anode)

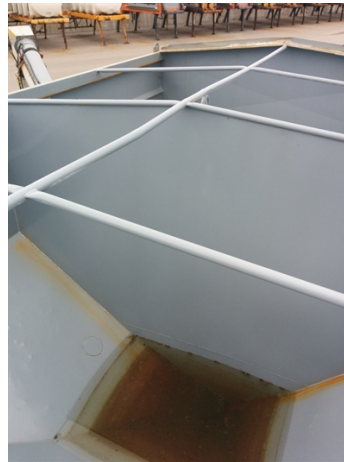
Hopper during Belzona application.

Hopper was grit blasted to the required level of cleanliness as recommended in the products IFU. After require QA/QC checks, Belzona was applied and post application testing was done for require parameters.

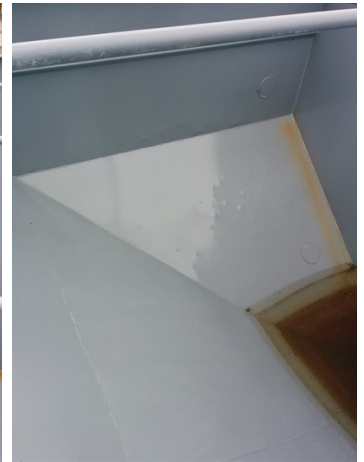
Hopper after a year in service.

Belzona was able to protect the hopper better than previously used coatings as after a year, hopper still appears in good shape.
