Belzona Saves Salt Hopper in a Municipal facility.

Industry: *Local Authorities & Municipalities*
 Application: *TCC-Tanks and Chemical Containment Areas*
 Substrate: *Carbon steel*
 Products: *Belzona 6111 (Liquid Anode)*

Customer Location: *Kitchener, Ontario*
 Application Date: *October 2013*

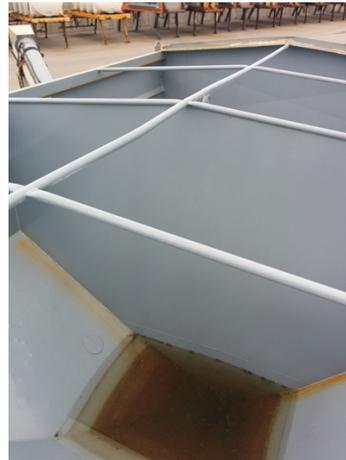
Hopper after a year in service.

Belzona was able to protect the hopper better than previously used coatings as after a year, hopper still appears in good shape.

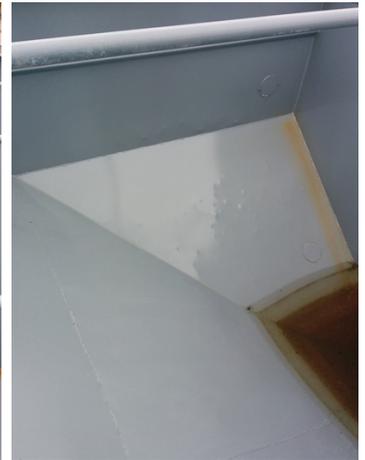
Close view after a year in service.
