# Concrete Stairs saved from further dilapidation.

ID: 9696

Industry: *Local Authorities & Municipalities*  
Application: *FPA-Floor Problem Areas*  
Substrate: *Concrete*  
Products: *Belzona 4111 (Magma-Quartz)*

Customer Location: *Ontario*  
Application Date: *September 2014*

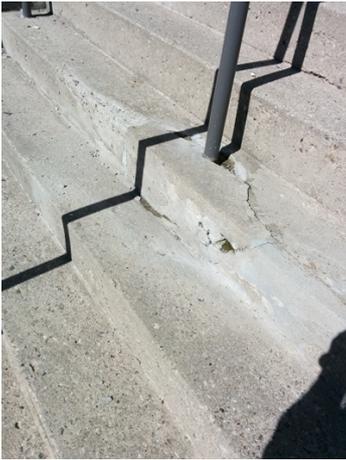
*Stairs was experiencing cracks along the railing pillar and was on the verge of falling apart.*

Cracks on stairs before repair.

Concrete stairs was on the verge of falling apart due to stress from the railings and customer wanted a fast repair that would enable the area opened to the public in the fastest way.

The weak parts of the concrete stairs was removed and vacuumed. The areas were subsequently rebuilt with Belzona 4111.

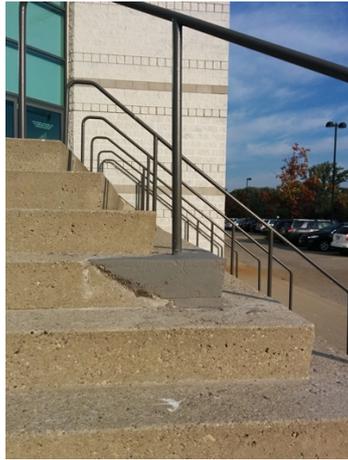
Further cracks .

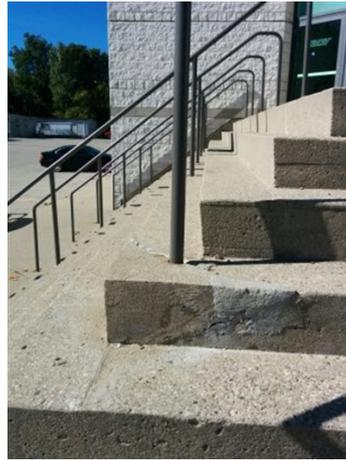
After surface preparation.

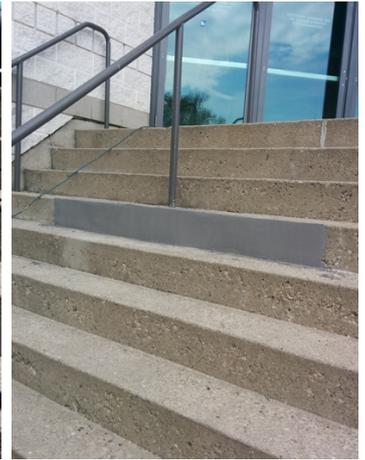
Stairs after repair.

Belzona repair was carried out and the area opened to for public use in matter of days.
