Concrete Stairs saved from further dilapidation.

ID: 9696

Industry: *Local Authorities & Municipalities*
Application: *FPA-Floor Problem Areas*
Substrate: *Concrete*
Products: *Belzona 4111 (Magma-Quartz)*

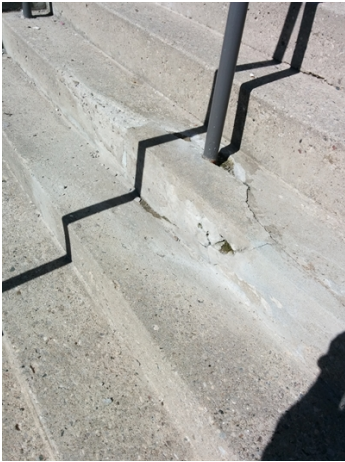
Stairs was experiencing cracks along the railing pillar and was on the verge of falling apart.

Cracks on stairs before repair.

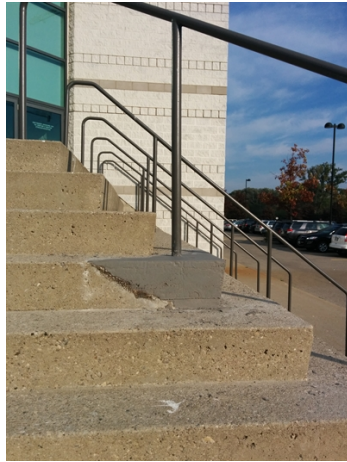
Further cracks .

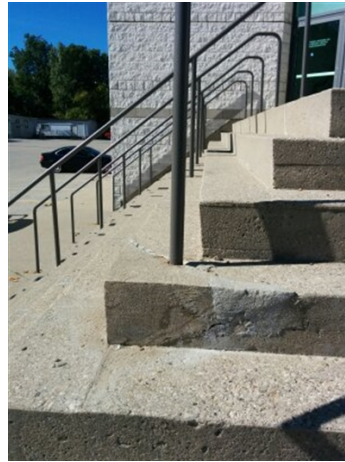
After surface preparation.

The weak parts of the concrete stairs was removed and vacuumed. The areas were subsequently rebuilt with Belzona 4111.

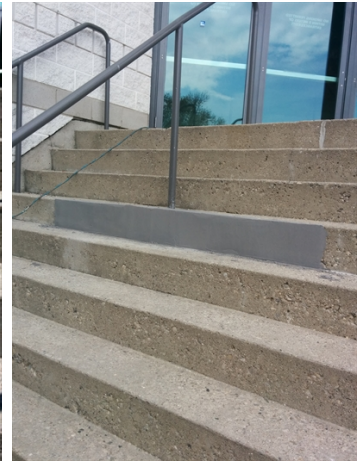
Stairs after repair.
