Hydroelectric water control gate part refurbished and protected

ID: 9698

Industry: Power
Application: VPF-Valves, Pipes and Fittings
Substrate: Stainless-steel
Products: Belzona 5811 (Immersion Grade)

Customer Location: Ontario
Application Date: August 2015

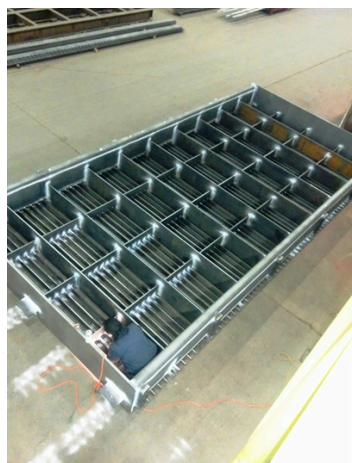
Parts of a control gate was newly fabricated and require protection form corrosion to extend their service years.

New control gate

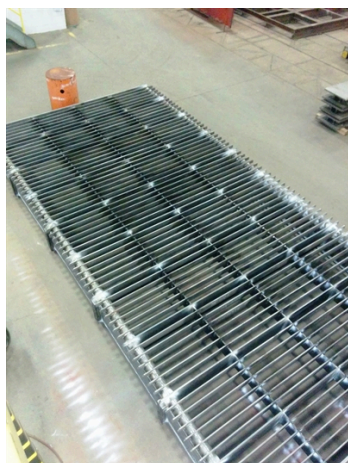
Control gate after surface preparation

The parts were sand blasted to the required conditions as stipulated on the product's IFU. It was then coated with two coats of Belzona 5811.

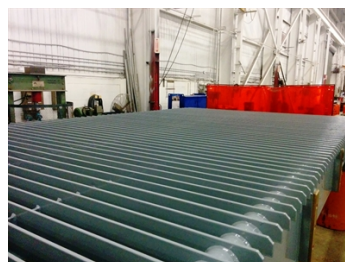
Application completed with Belzona 5811

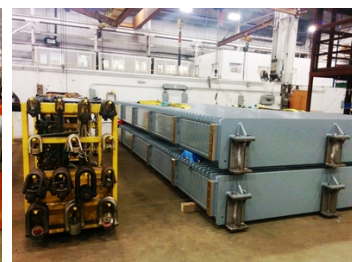
Application completed with Belzona 5811
