# Hydroelectric water control gate part refurbished and protected

ID: 9698

Industry: Power  
Application: VPF-Valves, Pipes and Fittings  
Substrate: Stainless-steel  
Products: Belzona 5811 (Immersion Grade)

Customer Location: Ontario  
Application Date: August 2015

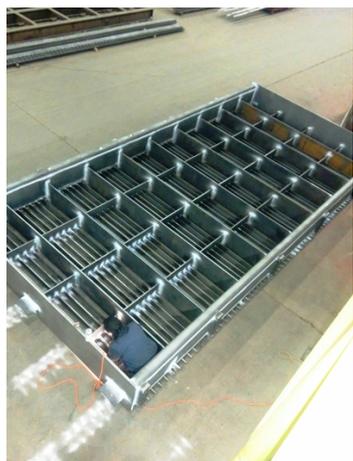
New control gate

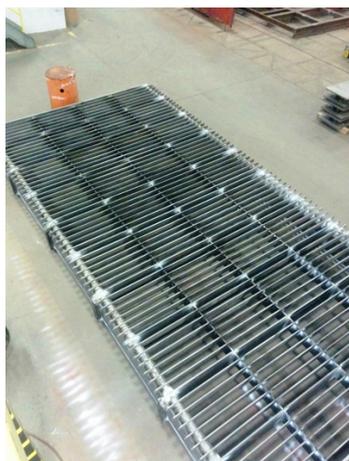
Control gate after surface preparation

The parts were sand blasted to the required conditions as stipulated on the product's IFU. It was then coated with two coats of Belzona 5811.

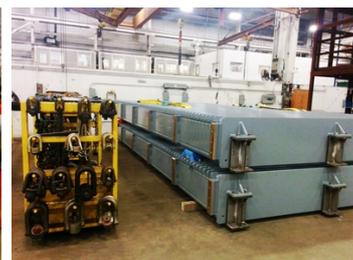
Application completed with Belzona 5811
