Gaylord Opryland Expansion Joint

Industry: *Buildings & Structures*
Application: *FPA-Floor Problem Areas*
Substrate: *Masonry*
Products: *Belzona 2211 (MP Hi-Build Elastomer), Belzona 2941 (Elastomer SP-Conditioner)*

Customer Location: *Nashville*
Application Date: *June 2023*

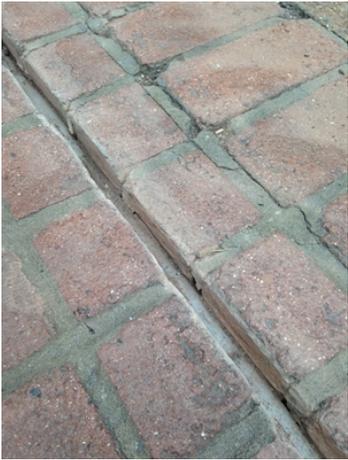
Customer had a failing expansion joint. It was also a trip hazard.

Expansion joint before application

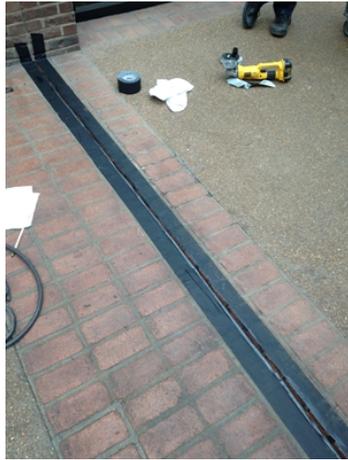
Application of Belzona 2211

Old failing joint was removed, and the joint was cleaned out. Tape was used to keep a straight line.

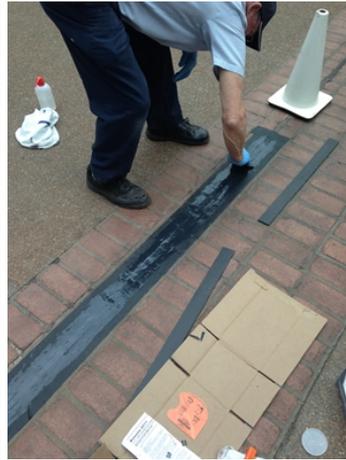
Application completed with Belzona 2211
