Tube mills are no problem for Belzona

Industry: Cement

Application: SHM-Solids Handling Machinery

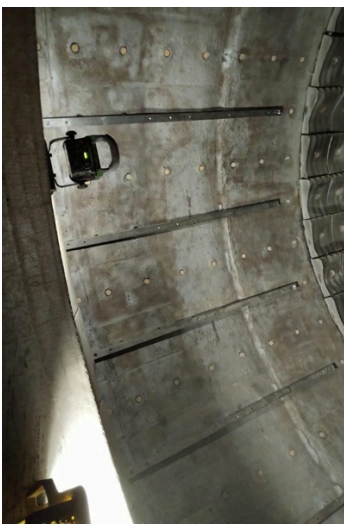
Tube mill grit blasted by the customer.

The surface to be repaired was grit blasted by the customer. A steel frame was prefabricated so that Belzona 4111 (Magma-Quartz) could be applied at the exact height. Another steel frame with different dimensions was prefabricated so that Belzona 1812 (Ceramic Carbide FP) could be applied at the exact height.

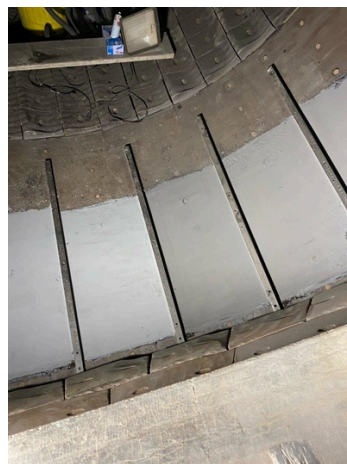
The damaged area repaired with Belzona 4111 (Magma-Quartz).

Installation of the auxiliary frame by the customer to achieve the correct height; conditioning with Belzona 4911 (Magma TX Conditioner), substrate resurfaced with up to 4mm Belzona 4111 (Magma-Quartz), roughening of the Belzona 4111, final layer approx. 4mm of Belzona 1812 (Ceramic Carbide FP) for wear protection. Due to the complicated geometry of the pre-drying chamber, only every second field was initially processed with Belzona 4911 (Magma TX Conditioner)/4111 (Magma-Quartz) (the mill was turned for ¼ in between), the final coating with Belzona 1812 (Ceramic Carbide FP) was also carried out in two stages – on every second field, the remaining ones in the next round. Unfortunately, there is no photo of the finished application.

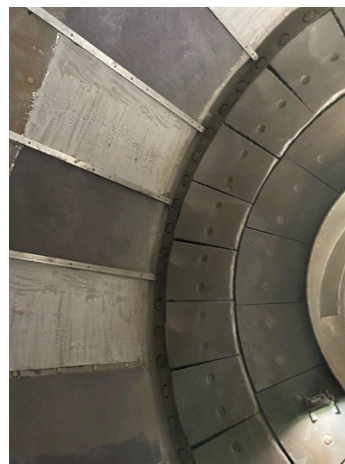
Close shot of the application in process.

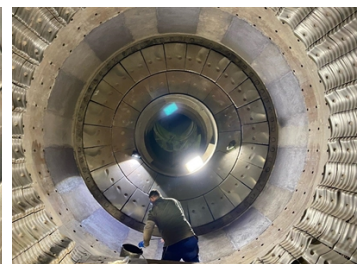
The damaged area half way covered with Belzona 1812 (Ceramic Carbide FP).
