Tube mills are no problem for Belzona

Industry: *Cement*

Application: *SHM-Solids Handling Machinery*

Application Date: *January 2021*

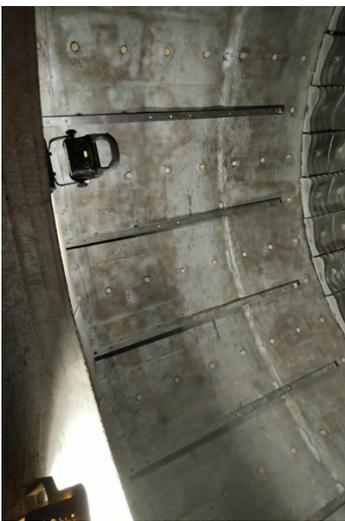
Tube mill grit blasted by the customer.

The surface to be repaired was grit blasted by the customer. A steel frame was prefabricated so that Belzona 4111 (Magma-Quartz) could be applied at the exact height. Another steel frame with different dimensions was prefabricated so that Belzona 1812 (Ceramic Carbide FP) could be applied at the exact height.

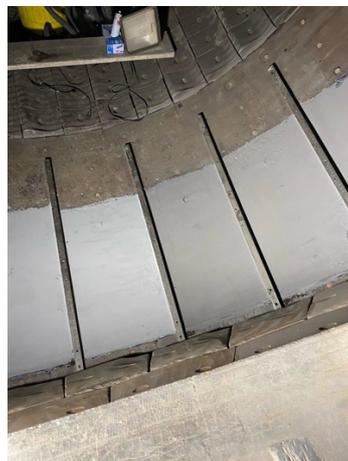
The damaged area repaired with Belzona 4111 (Magma-Quartz).

Installation of the auxiliary frame by the customer to achieve the correct height; conditioning with Belzona 4911 (Magma TX Conditioner), substrate resurfaced with up to 4mm Belzona 4111 (Magma-Quartz), roughening of the Belzona 4111, final layer approx. 4mm of Belzona 1812 (Ceramic Carbide FP) for wear protection. Due to the complicated geometry of the pre-drying chamber, only every second field was initially processed with Belzona 4911 (Magma TX Conditioner)/4111 (Magma-Quartz) (the mill was turned for ¼ in between), the final coating with Belzona 1812 (Ceramic Carbide FP) was also carried out in two stages – on every second field, the remaining ones in the next round. Unfortunately, there is no photo of the finished application.

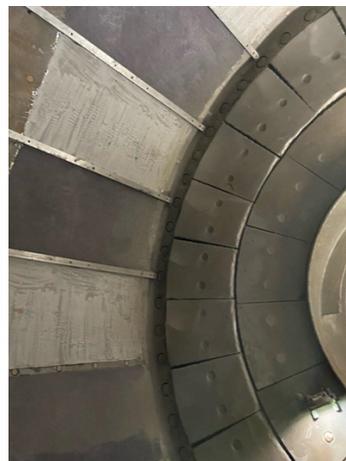
Close shot of the application in process.

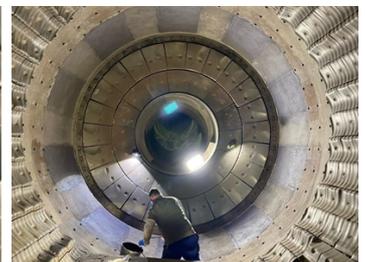
The damaged area half way covered with Belzona 1812 (Ceramic Carbide FP).
