An Auger in a concrete precast company gets the Belzona treatment.

ID: 9702

Industry: Cement
Application: SHM-Solids Handling Machinery

Substrate: Carbon steel
Products: Belzona 1812 (Ceramic Carbide FP), Belzona 9111 (Cleaner Degreaser)

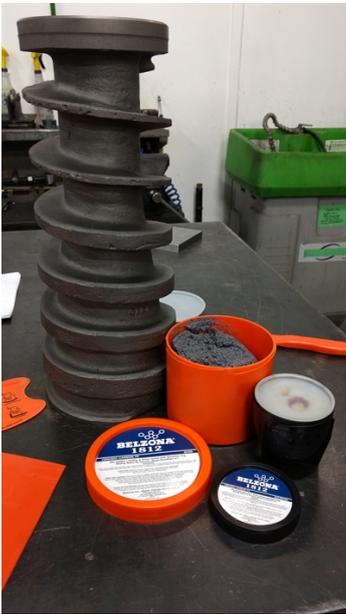
Auger after abrasive blasting.

The part was grit blasted to the required level of cleanliness as stipulated on the product's IFU. The vanes were then covered with Belzona 1812 for optimum abrasion resistance.

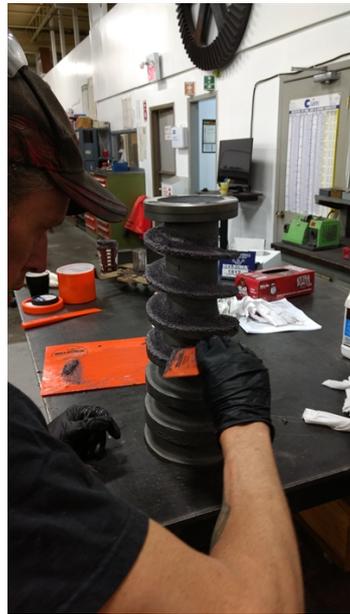
Auger during application of Belzona 1812.

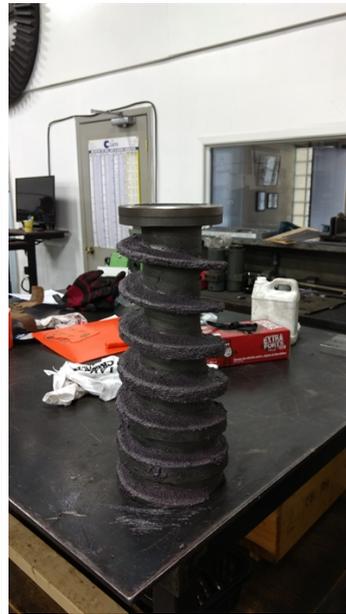
Application completed with Belzona 1812.

The customer put the auger in service and inspected it after few weeks to ascertain the level of protection by Belzona. They were pleased to see that the equipment itself is isolated from the abrasive nature of the concrete components.
