Heavily corroded air handling unit needed some Belzona

ID: 9703

Products: Belzona 1161 (Super UW-Metal), Belzona 1981 (SuperWrap II)

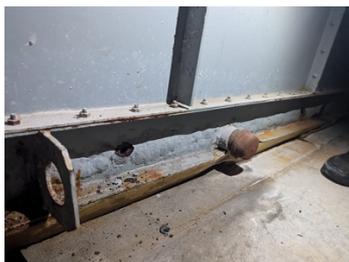
Unit before cleaning.

The customer left these units untreated and unprotected for many years, resulting in significant deterioration. Welding was not an option due to the thinness of the remaining metal. As a solution, they decided to entrust us with the repair, aiming to restore and extend the service life of these units.

All structurally unsound steel areas were removed, and the entire surface was mechanically roughened to ensure proper adhesion. The removal of rusted steel left several large holes, which were addressed by installing metal reinforcing plates. Belzona 1161 was then applied for bonding and sealing, followed by the use of Belzona 9381 in combination with 9371 fiberglass mesh to provide additional reinforcement and durability.
