Heavily corroded air handling refurbished with Belzona 5831

ID: 9704

Industry: Heating, Ventilation & Air Conditioning
Application: TCC-Tanks and Chemical Containment Areas
Substrate: Carbon steel
Products: Belzona 5831 (ST-Barrier)

Customer Location: Ontario
Application Date: August 2024

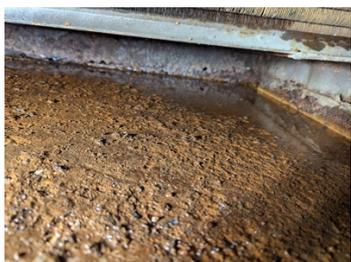
Two air handling units were heavily corroded and leaking in several areas. The whole basin needed to be coated and properly sealed.

One of the basins before cleaning.

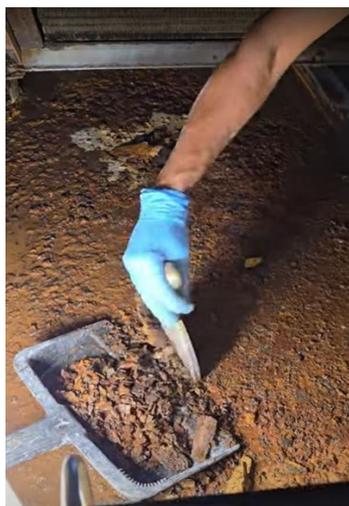
Basin during surface preparation.

All the rusty areas were scrapped and removed with a putty knife followed by power tool cleaning. Then two coats of Belzona 5831 were applied. The system was allowed to cure for 2 days before being put back in service.

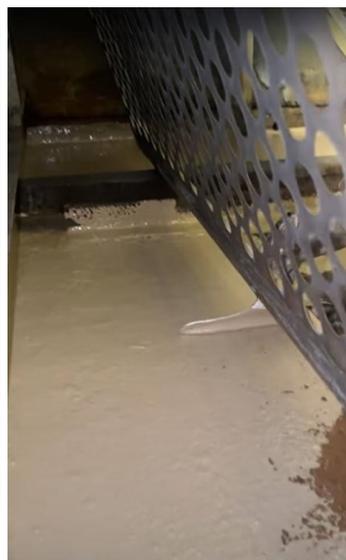
During application of Belzona 5831

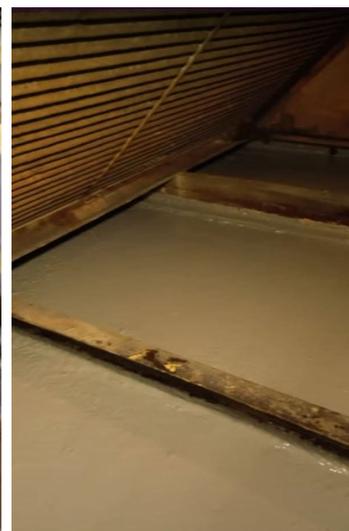
Both units after coating application.
