Hospital Drain

ID: 9706

Application: FPA-Floor Problem Areas

Products: Belzona 4111 (Magma-Quartz), Belzona 5231 (SG Laminate)

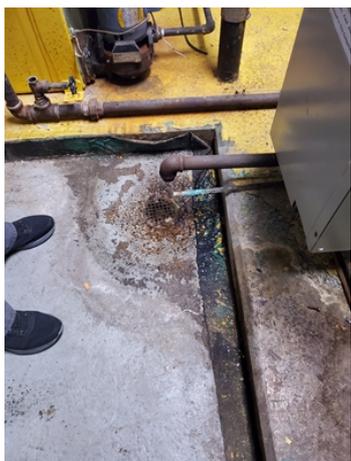
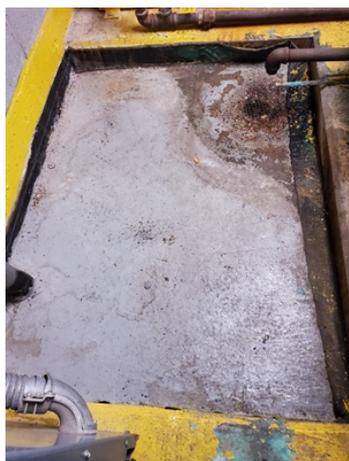
Drain was leaking in patients room.

Drain condition before repair with Belzona

Concrete was prepared with hand tools and cleaned before doing the repair.

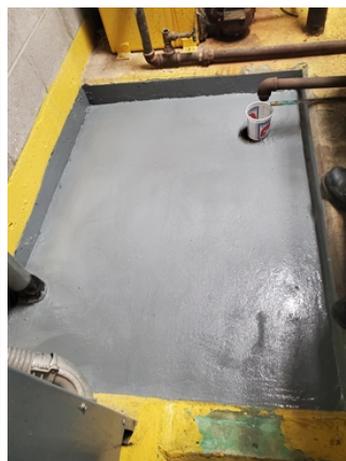
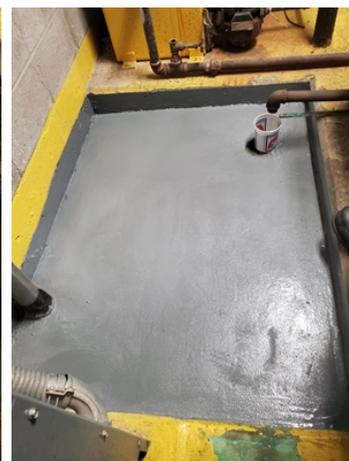
Final application of Belzona solution
