# Concrete Chemical Trough Protection with Belzona

ID: 9714

**Industry:** General Industry  
**Application:** TCC-Tanks and Chemical Containment Areas  
**Substrate:** Concrete  
**Products:** Belzona 1111 (Super Metal), Belzona 4341 (Magma CR4)

**Customer Location:** Gordonsville TN  
**Application Date:** December 2024

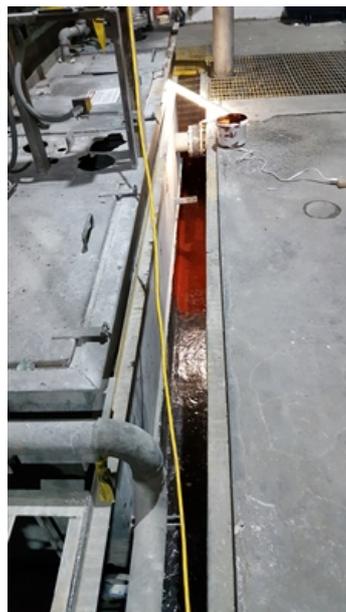
Trough was damaged due to age and acid attack. Customer required a Belzona solution.

Overview of repair area.

Overview after surface preparation was completed.

Application in progress.

Completed application.

Contractor had to naturalize and clean concrete then repair before coating. They had to monitor the air quality. Belzona 1111 was used to rebuild the areas and Belzona 4341 to provide chemical resistance protection.
