Attritor Repair with Belzona

ID: 9715

Industry: *Chemical & Petrochemical*
Application: *SHM-Solids Handling Machinery*

Substrate: *Masonry*
Products: *Belzona 1511 (Super HT-Metal), Belzona 1813, Belzona 9811*

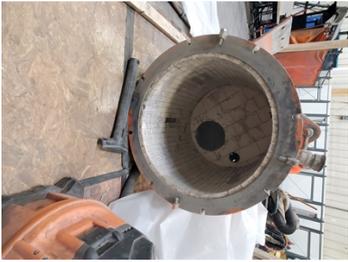
Overview of repair area.

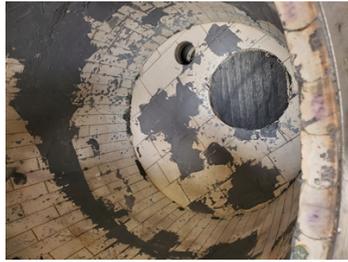
Overview of repair area.

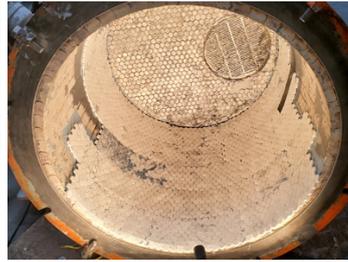
Application of Belzona 9811 tiles (bonded with Belzona 1511).

Equipment was cleaned Belzona 1511 was used to build up low areas and to bond in Belzona 9811 tiles. Belzona 1813 was used as the grout due to temperature requirements.

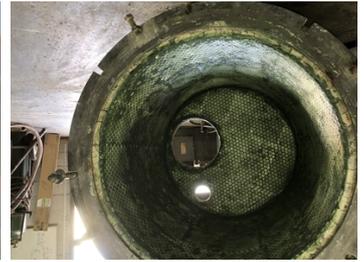
Grout completed with Belzona 1813.
