BELZONA REPAIRS STEPS AT CIVIC CENTER AUDITORIUM IN 1984. 40 YEARS LATER THE BELZONA REPAIR IS HOLDING STRONG.

Application: FPA-Floor Problem Areas

Products: Belzona 4111 (Magma-Quartz), Belzona 4911 (Magma TX Conditioner)

Customer Location: Savannah, Georgia, USA

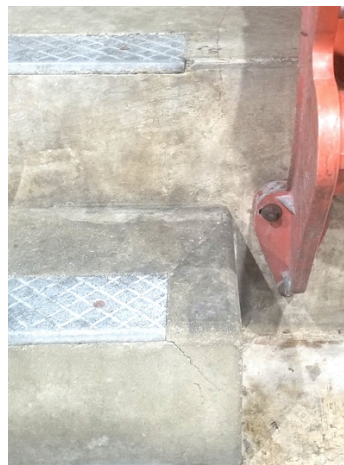
The nose tread on the concrete steps have a metal plate. Over the years, expansion and contraction of the metal plate broke off the concrete end pieces. This problem became a safety issue for trip / fall risk.

Overview of the 1984 Civic Center Spalled Steps.

In 1984, Jim Lynch with DBR Associates sold and applied the BELZONA products. The spalled concrete was removed and the concrete was wired brushed. Holes were drilled in the spalled concrete area and two or more 3" bolts were installed within the spalled areas to insure torsional rigidity. The spalled area was cleaned and the BELZONA 4911 (Magma TX Conditioner) applied to the area to be repaired. Plywood forms were placed on the sides of the steps and held in place with duct tape. BELZONA 4111 (High Performance Concrete Repair and Rebuild Composite) was applied by trowel and beveled where the metal nose tread met the repaired area allowing for expansion and contraction.

Inspection after 40 years revealed the BELZONA repair to be in good condition and no wear on BELZONA 4111 repair areas.
