BELZONA REPAIRS STEPS AT CIVIC CENTER AUDITORIUM IN 1984. 40 YEARS LATER THE BELZONA REPAIR IS HOLDING STRONG.

ID: 9717

Customer Location: Savannah, Georgia, USA

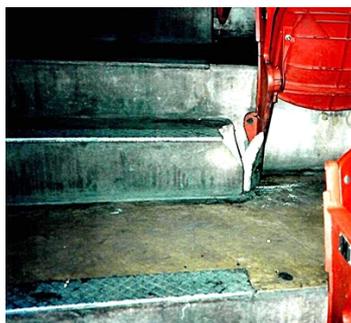
The nose tread on the concrete steps have a metal plate. Over the years, expansion and contraction of the metal plate broke off the concrete end pieces. This problem became a safety issue for trip / fall risk.

Overview of the 1984 Civic Center Spalled Steps.

In 1984, Jim Lynch with DBR Associates sold and applied the BELZONA products. The spalled concrete was removed and the concrete was wired brushed. Holes were drilled in the spalled concrete area and two or more 3" bolts were installed within the spalled areas to insure torsional rigidity. The spalled area was cleaned and the BELZONA 4911 (Magma TX Conditioner) applied to the area to be repaired. Plywood forms were placed on the sides of the steps and held in place with duct tape. BELZONA 4111 (High Performance Concrete Repair and Rebuild Composite) was applied by trowel and beveled where the metal nose tread met the repaired area allowing for expansion and contraction.

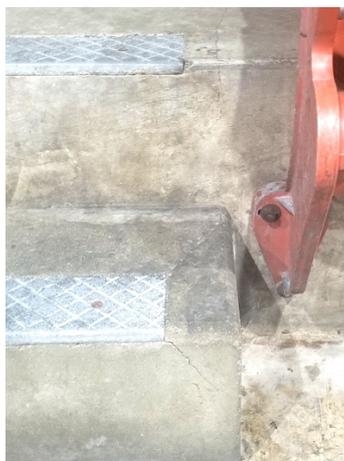
Savannah Civic Center Repaired with Belzona 4111.

Inspection after 40 years revealed the BELZONA repair to be in good condition and no wear on BELZONA 4111 repair areas.
