# Pump Shaft Repair

ID: 9718

Application: FBC-Fans, Blowers and Compressors

Products: Belzona 1131 (Bearing Metal)

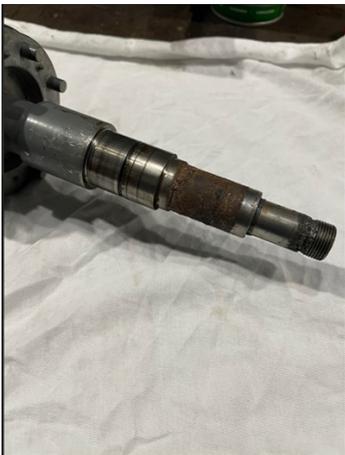
One of the pump shafts in the machinery shop showed damage near the sealing area. Following our initial consultation, they ask for guidance on how to fix it without having to replace it. Because of its self-lubricating qualities, Belzona Bearing Metal 1131 was recommended.

Shaft Initial Condition

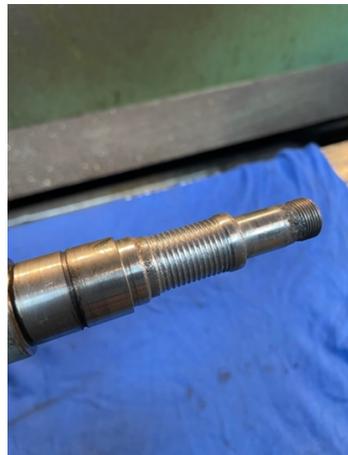
Surface prepared

Workshop execute the FBC-12 procedure from the System Leaflets. A lathe was used for the surface preparation and the undercut of the excess material.

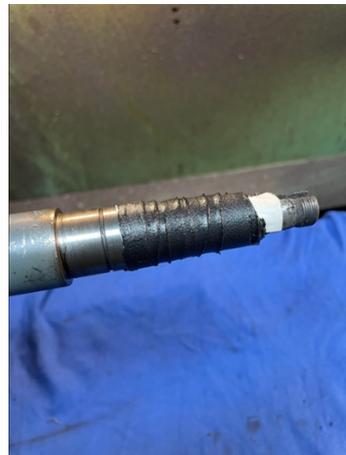
Bearing Metal Application

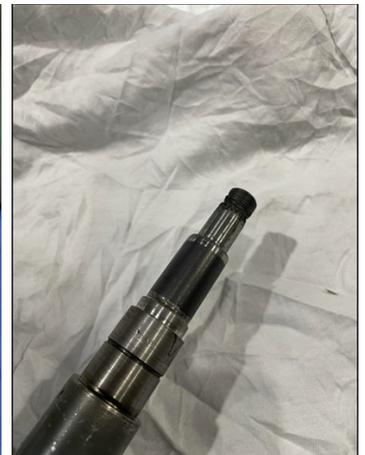
Complete repair

Belzona provided the client with a quick and reasonably priced repair. Both the end user and the workshop were quite happy with the result.
