BELZONA IN-SITU TANK REPAIR

ID: 972

Customer Location: Automobile component manufacturer,
UK

Paint booth process water tank

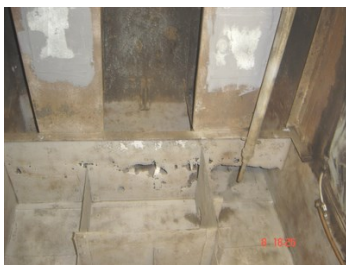
Corrosion and leaking tank. To replace tank with new was costly and would result in production downtime of 7-10 working days.

* Tank cleaned and shot blasted , * Vacuum column prior to plate being bonded , * Remedial work/plates bonded in place , * Tank complete after 2 coats of Belzona® 5811 ,

Application was carried out in accordance with Belzona Know-How System Leaflets TCC-1 & -3. doubler plates were bonded over perforated steelwork before applying corrosion resistant coating.
