# BELZONA IN-SITU TANK REPAIR

Paint booth process water tank

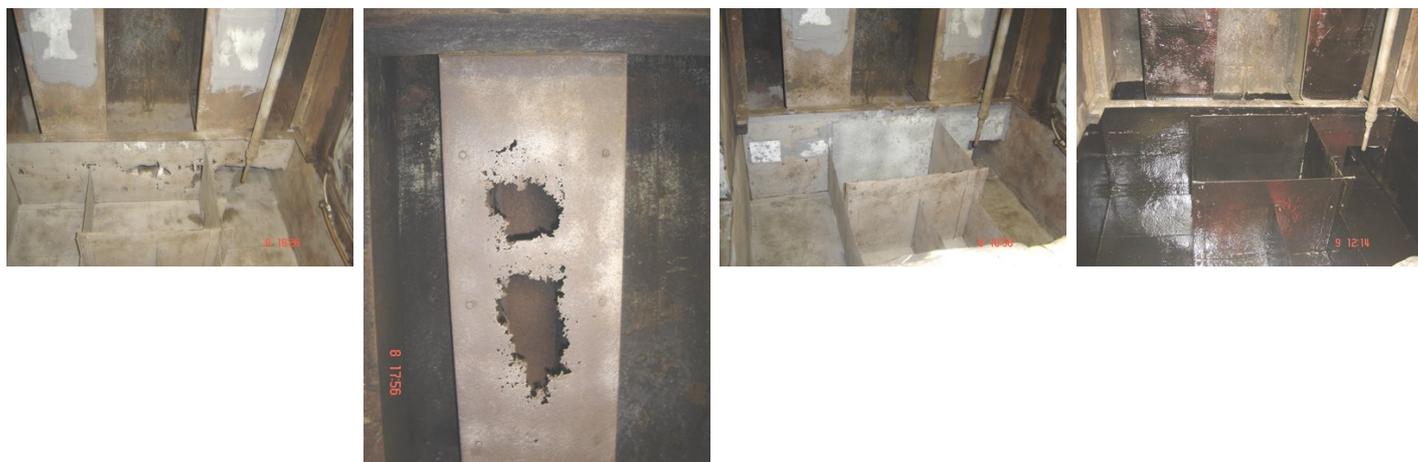
*Corrosion and leaking tank. To replace tank with new was costly and would result in production downtime of 7-10 working days.*

\* Tank cleaned and shot blasted , \* Vacuum column prior to plate being bonded , \* Remedial work/plates bonded in place , \* Tank complete after 2 coats of Belzona® 5811 ,

Application was carried out in accordance with Belzona Know-How System Leaflets TCC-1 & -3. doubler plates were bonded over perforated steelwork before applying corrosion resistant coating.
