Municipality Saves Money by Coating Pumps with Belzona

Customer Location: Dayton, OH USA

Application: CEP-Centrifugal Pumps

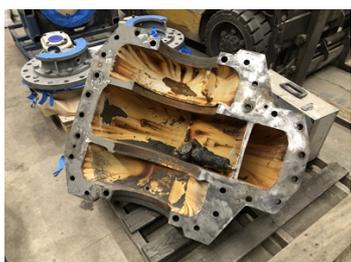
Condition of pump casing when pulled from service.

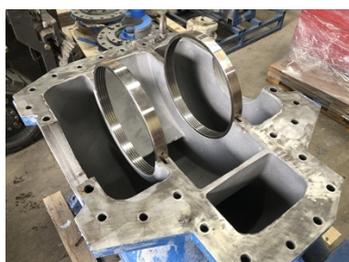
Pump grit blasted and new wear rings positioned.

Pump was grit blasted then degreased using Belzona 9111 (Cleaner/Degreaser). Wear rings were cast and cutwater was formed using Belzona 1311 (Ceramic R-Metal). Then one coat of Belzona 1321 (Ceramic S-Metal) was applied followed by two coats of Belzona 1341N (Supermetalglide).

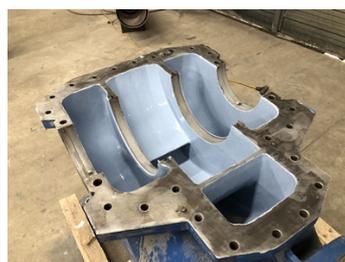
Finished application with the wear rings rebuilt and the pump casing coated with Belzona 1341N (Supermetalglide).

To replace this pump was upwards of \$35,000 in 1998 dollars. Belzona was able to rebuild the wear rings, cutwater and apply two coats of their energy efficiency coating and return this pump to service in a few days. The replacement part was going to take more than six months to obtain.
