Municipality Saves Money by Coating Pumps with Belzona

Customer Location: Dayton, OH USA

Application: CEP-Centrifugal Pumps

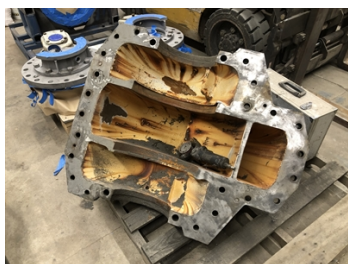
Condition of pump casing when pulled from service.

To replace this pump was upwards of \$35,000 in 1998 dollars. Belzona was able to rebuild the wear rings, cutwater and apply two coats of their energy efficiency coating and return this pump to service in a few days. The replacement part was going to take more than six months to obtain.

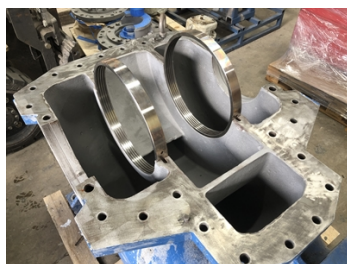
Pump grit blasted and new wear rings positioned.

Pump was grit blasted then degreased using Belzona 9111 (Cleaner/Degreaser). Wear rings were cast and cutwater was formed using Belzona 1311 (Ceramic R-Metal). Then one coat of Belzona 1321 (Ceramic S-Metal) was applied followed by two coats of Belzona 1341N (Supermetalglide).

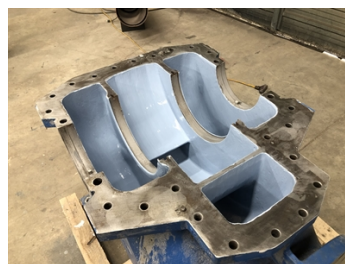
Finished application with the wear rings rebuilt and the pump casing coated with Belzona 1341N (Supermetalglide).
