# Engine Room Corrosion Repair

ID: 9722

Industry: *Marine*  
Application: *ENC-Engines and Casings*  
Substrate: *Other*  
Products: *Belzona 5831 (ST-Barrier)*

Customer Location: *Melbourne*  
Application Date: *September 2023*

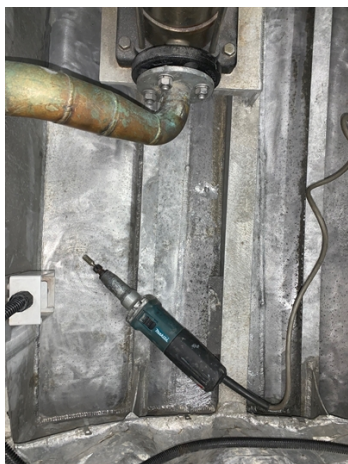
A ferry operator experienced a problem with severe corrosion in a ferry's engine room which required immediate repairs and the application of a preventative coating to provide corrosion protection.

Engine room flooring to be repaired.

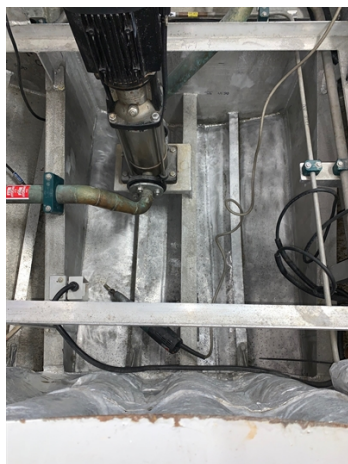
Surface preparation carried out using handheld power tools due to confined space.

Due to the confined space of the repair area, hand held power tools were required to carry out the surface preparation. Once complete, 2 coats of Belzona 5811 was applied achieving a 500 micron film thickness.

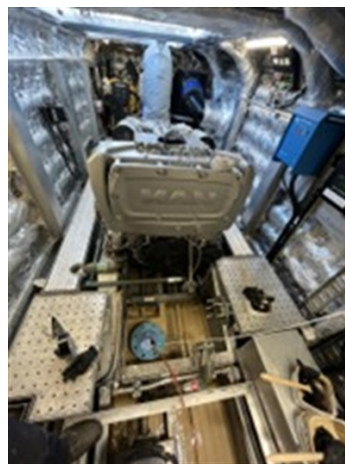
Ferrie engine room proved to be a difficult application due to confined space.

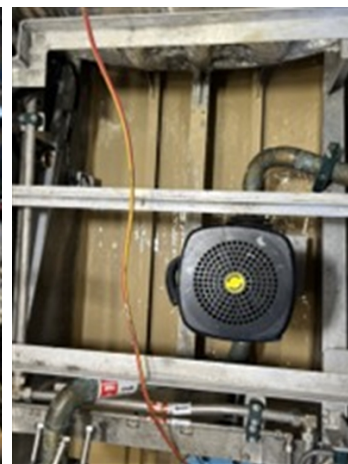
Belzona 5831 coated carried out successfully.

Following the repair work and surface preparation, Belzona 5831 was applied to provide long-term corrosion prevention.
