# Engine Room Corrosion Repair

ID: 9722

Industry: Marine  
Application: ENC-Engines and Casings  
Substrate: Other  
Products: Belzona 5831 (ST-Barrier)

Customer Location: Melbourne  
Application Date: September 2023

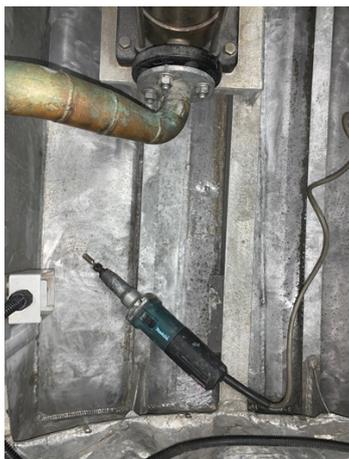
A ferry operator experienced a problem with severe corrosion in a ferry's engine room which required immediate repairs and the application of a preventative coating to provide corrosion protection.

Engine room flooring to be repaired.

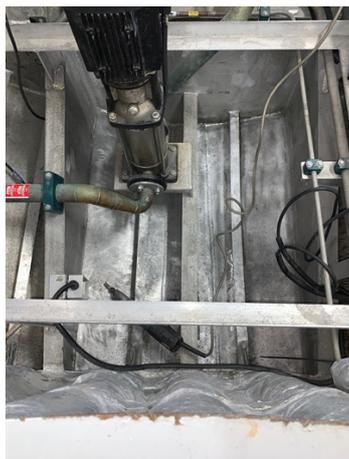
Surface preparation carried out using handheld power tools due to confined space.

Due to the confined space of the repair area, hand held power tools were required to carry out the surface preparation. Once complete, 2 coats of Belzona 5811 was applied achieving a 500 micron film thickness.

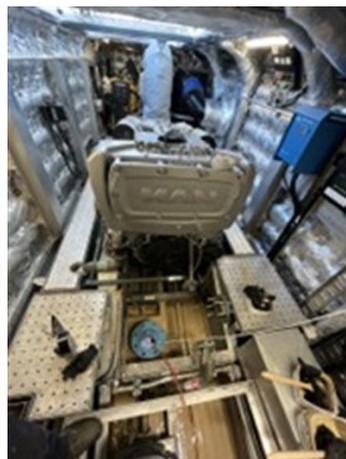
Ferrie engine room proved to be a difficult application due to confined space.

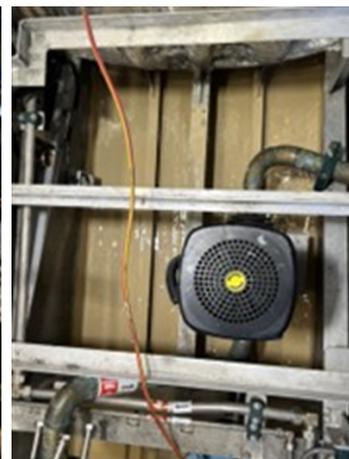
Belzona 5831 coated carried out successfully.

Following the repair work and surface preparation, Belzona 5831 was applied to provide long-term corrosion prevention.
