# Chiller Repair and Coating

ID: 9723

Application: HEX-Heat Exchangers

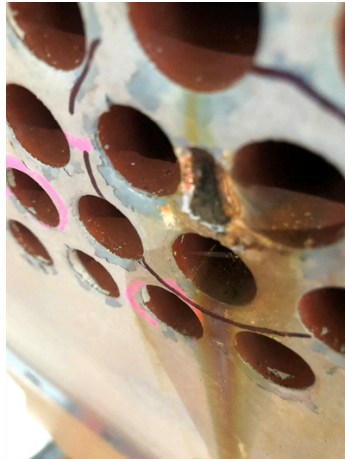
Close up of the damage to be addressed.

After abrasive blasting the surfaces, Belzona 1111 Super Metal was employed to rebuild the eroded sections followed by a top protective coating of Belzona 1321.

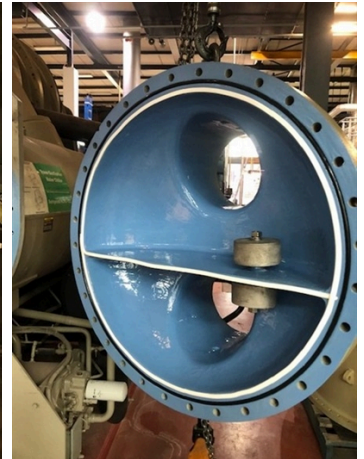
Completed coating on the end cover of the chiller unit.
