Chiller Repair and Coating

ID: 9723

Application: HEX-Heat Exchangers

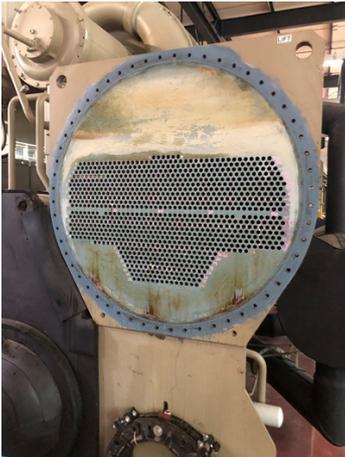
After regular service, the chiller face plates and end covers had suffered erosion damage and required repairing.

Chiller face plate during inspection.

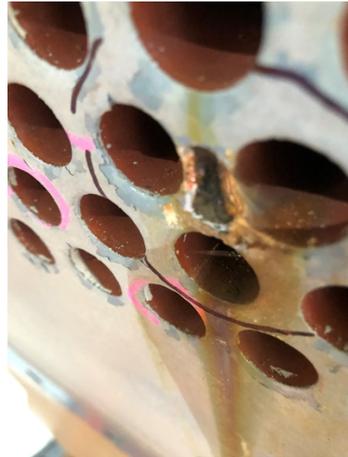
Close up of the damage to be addressed.

After abrasive blasting the surfaces, Belzona 1111 Super Metal was employed to rebuild the eroded sections followed by a top protective coating of Belzona 1321.

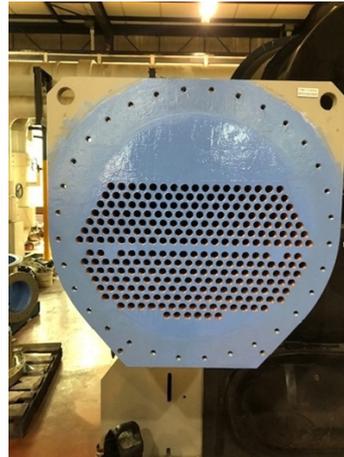
Completed repair and coating using BELZONA on the face plate.

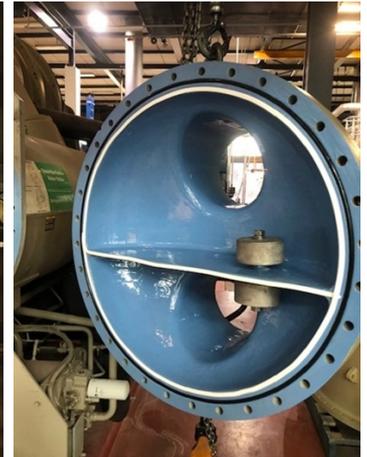
Completed coating on the end cover of the chiller unit.
