Ferry Capstan winch rebuilt with Belzona 1111

ID: 9724

Industry: *Marine*
Application: *SOS-Ships and Offshore Structures*

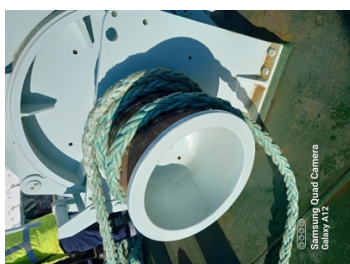
A capstan used for hauling mooring ropes was over coiling due to an insufficient chamfer. Build up using weld overlay would be prohibitively expensive & time consuming within the timeframe available.

Ropes overcoiling

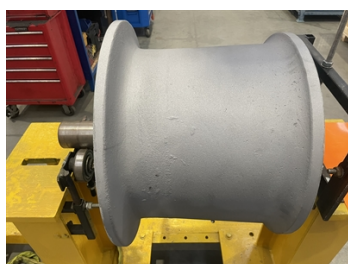
Grit blast surface preparation

The capstans were grit blasted to SA2.5 & minimum 75 microns. Belzona 1111 was then used to build a larger chamfer.

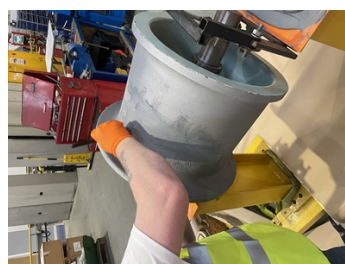
Wetting out the surface

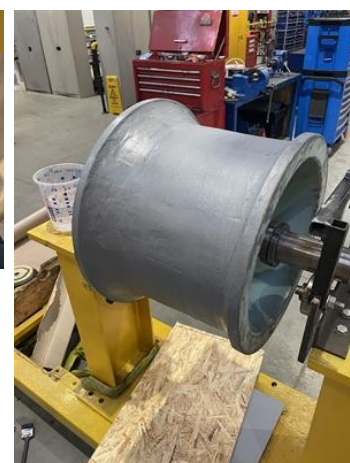
Build up of Belzona 1111
