# Ferry Capstan winch rebuilt with Belzona 1111

ID: 9724

Industry: *Marine*  
Application: *SOS-Ships and Offshore Structures*

Customer Location: *Scotland, UK*  
Application Date: *October 2024*

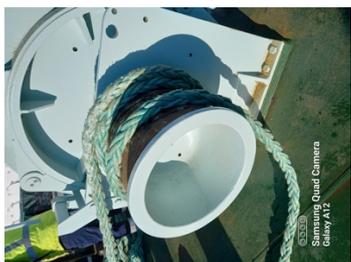
*A capstan used for hauling mooring ropes was over coiling due to an insufficient chamfer. Build up using weld overlay would be prohibitively expensive & time consuming within the timeframe available.*

Ropes overcoiling

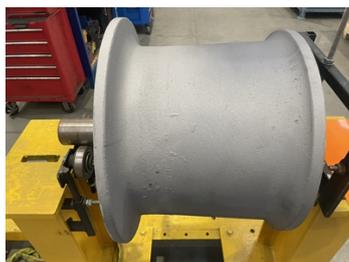
Grit blast surface preparation

The capstans were grit blasted to SA2.5 & minimum 75 microns. Belzona 1111 was then used to build a larger chamfer.

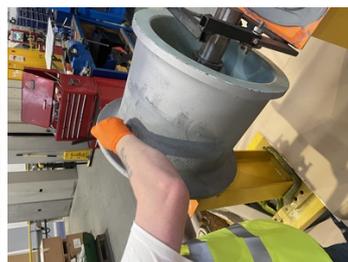
Wetting out the surface

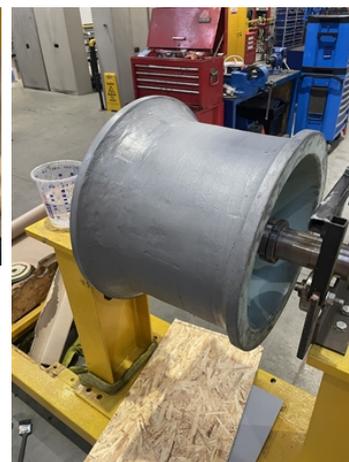
Build up of Belzona 1111
