Belzona Coating Nets an Increase of 700 GPM on Water Municipality Pump

Industry: Water / Wastewater
Application: CEP-Centrifugal Pumps
Substrate: Cast Iron
Products: Belzona 1311 (Ceramic R-Metal), Belzona 1341N (Supermetalgilde), Belzona 9411 (Release Agent)

Customer Location: Columbus, OH
Application Date: September 2019

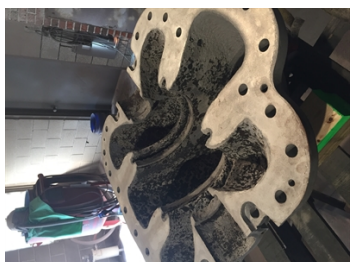
Serious corrosion impacted efficiency. The wear rings were rebuilt also.

This pump was grit blasted to SSPC SP 10 near white finish. The cutwater was rebuilt by tack welding expanded metal and then using Belzona 1311 (Ceramic R-Metal) to reform it. The wear ring seats were rebuilt using Belzona 1311 (Ceramic R-Metal) and using new wear rings that were coated with Belzona 9411 (Release Agent) as formers. After these repairs were properly cured, two 10-mil coats of Belzona 1341N (Supermetalgilde) was applied.

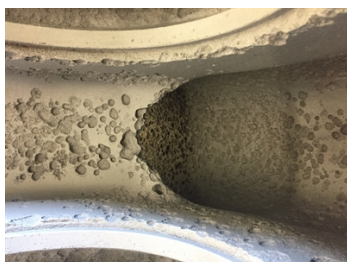
Cutwater was severely eroded.

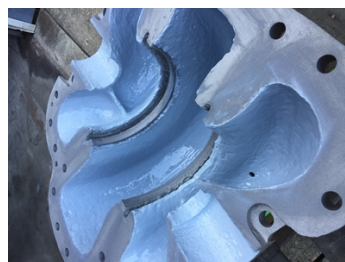
Picture shows completed application of Belzona 1341 (Supermetalgilde) on the top half of the casing.

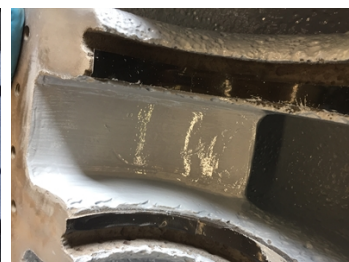
This picture shows the cutwater and wear rings rebuilt and coated.
