# IN SITU SHAFT REPAIR WITH BELZONA

ID: 973

Customer Location: *Chemical Producer, UK*  
Application Date: *August 2003*

Substrate: *EN Grade Hardened Steel*  
Products: *Belzona® 1111 (Super Metal)*

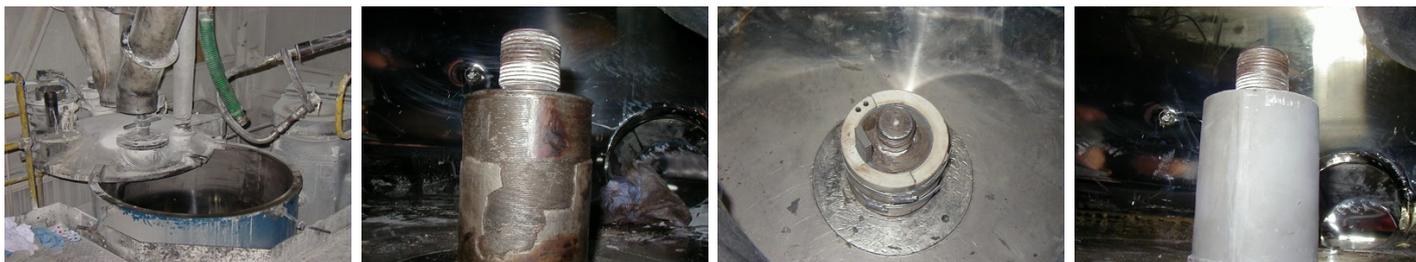
*Customer had un-scheduled failure of mixer vessel drive shaft which had previously been repaired using metal spraying.*

\* Mixer Vessel , \* Failed Metal Sprayed Shaft , \* Form tool in position , \* Finished Shaft ,

Old metal sprayed material was totally removed and shaft rebuilt using Belzona System Leaflet MPT-2. Former was made to allow repair to be completed in-situ.
